Pit 23 Groundwater

Assessment of Seepage Indicator Exceedances

Prepared for Iluka Resources Limited
November 2018

S180265 RP2

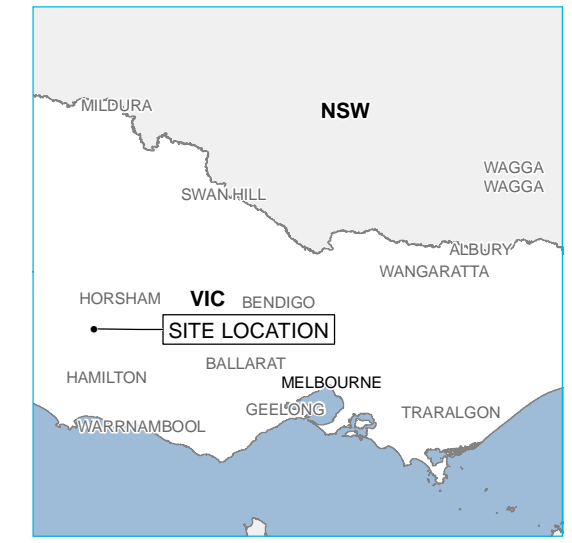
Figure 2.1
Monitoring locations
sampled during 2017
Iluka Resources
Douglas pit 23

- KEY**
- Groundwater monitoring site
 - Surface water monitoring site
 - Pre-mine drainage
 - Pit
 - Swamps and wetland

Table 2.8 shows the ion balance errors manually calculated for each sample taken at McGlashin Swamp, while Table 2.9 compares manually calculated ion balance errors from other surface water and groundwater monitoring locations at Douglas to laboratory supplied values. Locations of all monitoring points sampled during the 2017 calendar year are also shown in Figure 2.1.

McGlashin Swamp is one of a number of swamps located in the White Lake depression with its water quality parameters currently monitored by Iluka at monitoring point DUSW24 (Figure 2.1). North of McGlashin Swamp lie White Lake and Bitter Swamp with Ti Tree Swamp located to the south west. Over a dozen smaller unnamed swamps/depressions which may temporarily hold water are located in the vicinity, within 1 km of McGlashin Swamp.

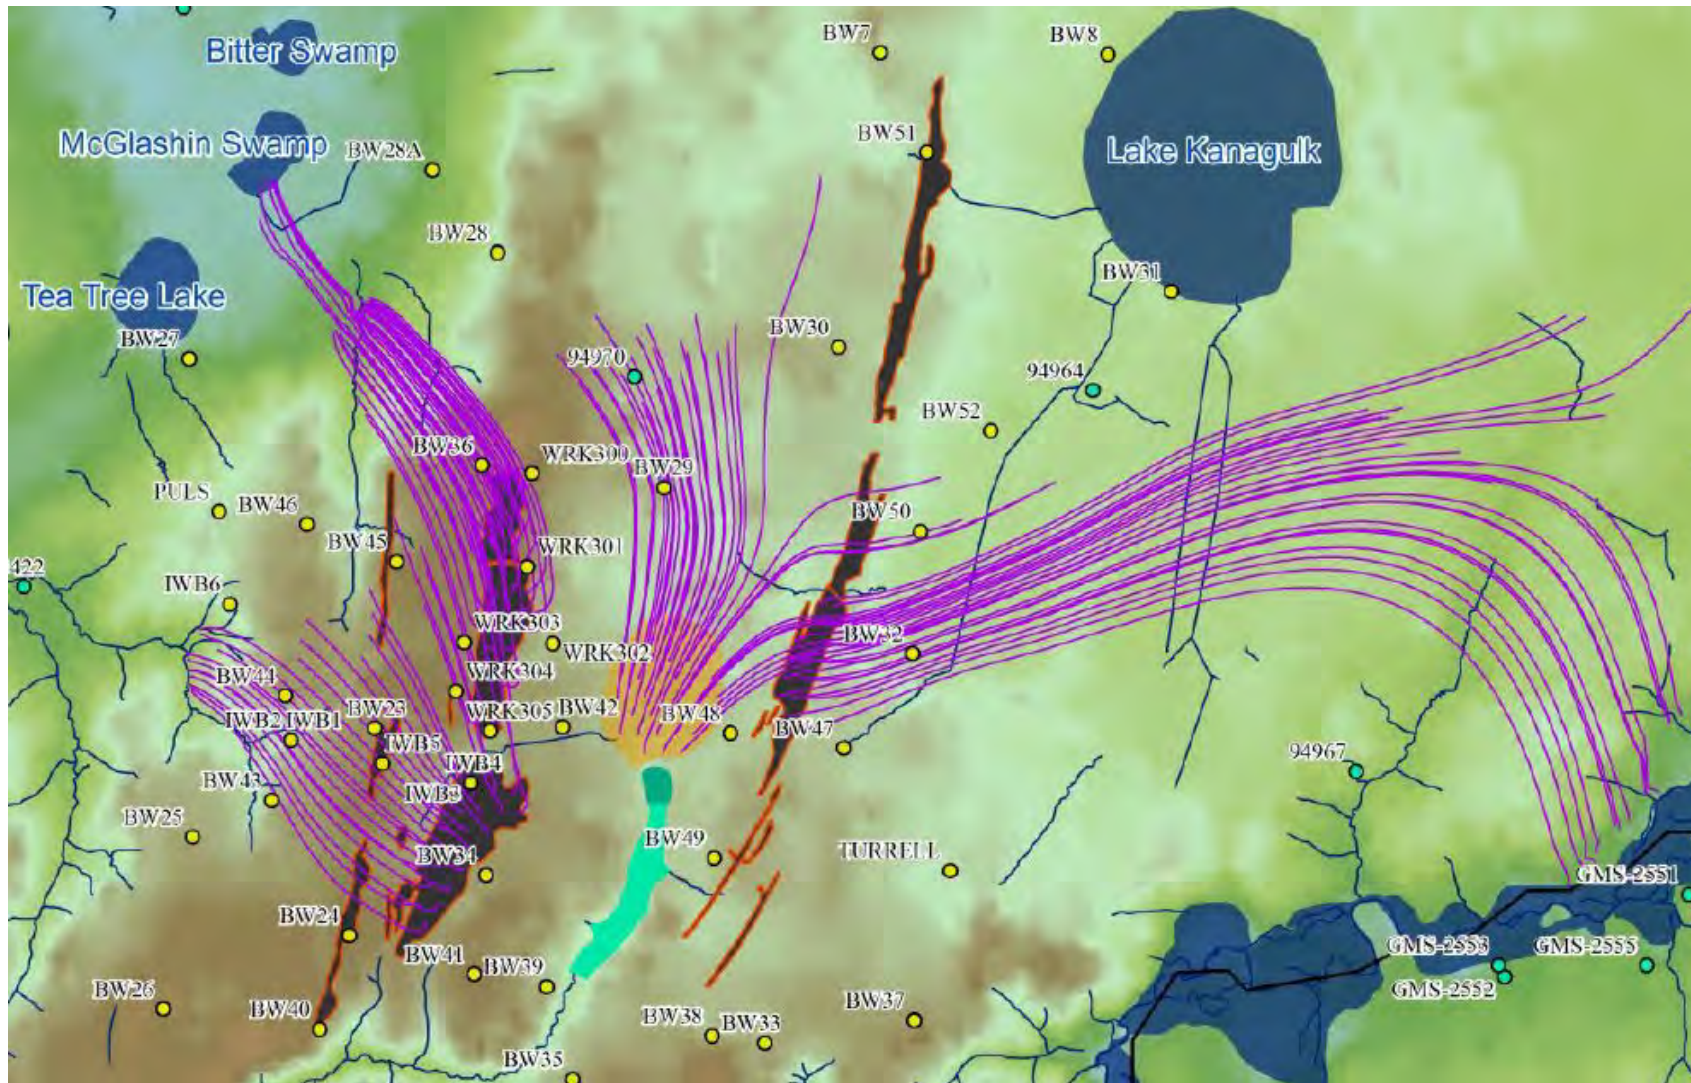
Figure 3.1 Particles originating from Pit 5, Pit 19, Pit 22, Pit 23 and the TSF tracked across the Douglas mine site (CDM Smith 2015)

CDM Smith (2014, 2015) has produced two reports which model the groundwater system across the Douglas mine site, with attention given to groundwater seepage from Pit 23. These studies found that groundwater seepage from Pit 23 would flow to the north-west, eventually discharging to the surface at McGlashin Swamp, the North-West Drainage Line, or through evapotranspiration. The modelled groundwater seepage flow paths are shown in Figure 3.1.

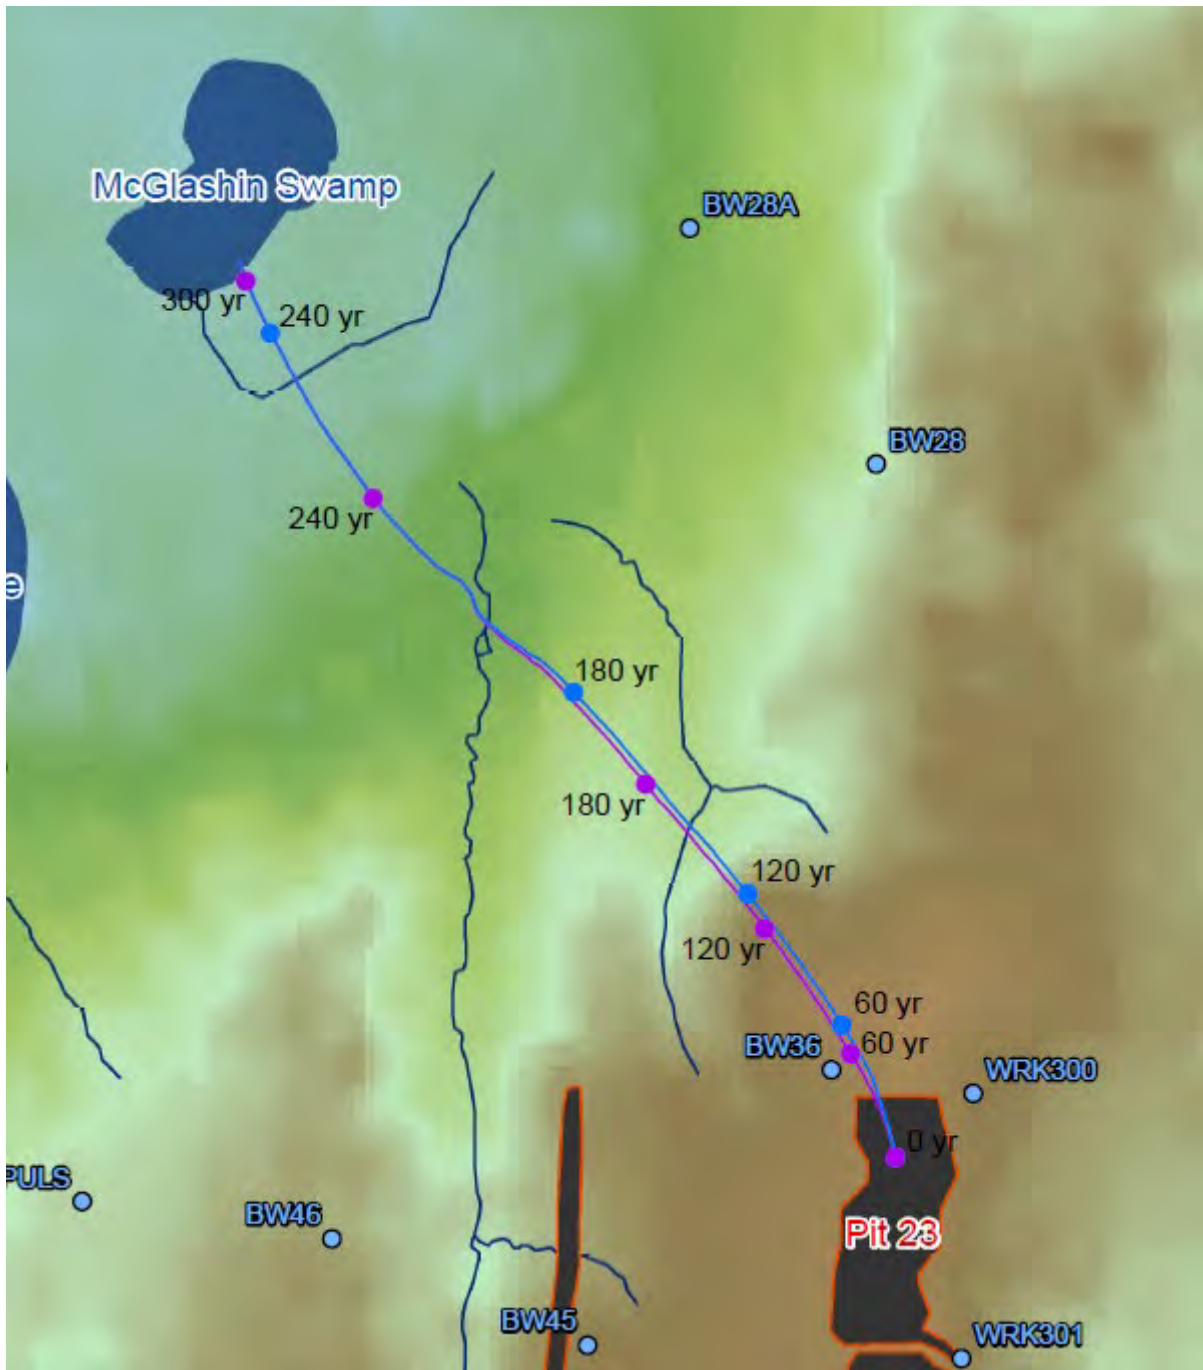
Figure 3.2 Pit 23 seepage particle tracking. Purple and blue represent the base and future disposal cases respectively (CDM Smith 2014)

Figure 3.2 shows the modelled particle tracks and travel times, where the purple and blue lines represent the base and future disposal cases respectively. This figure shows that groundwater particles are expected to take at least 240 years to reach McGlashin Swamp, which corresponds to the year 2251 as by-product disposal into Pit 23 began in 2011. CDM Smith (2015) modelled uncertainty cases beyond what is shown in Figure 3.2 and found particle arrival years to McGlashin Swamp from Pit 22/Pit 23 ranging from 2140 to 2160. In any case, these modelled scenarios suggest it is very unlikely that by-product seepage from Pit 23 has reached McGlashin Swamp.

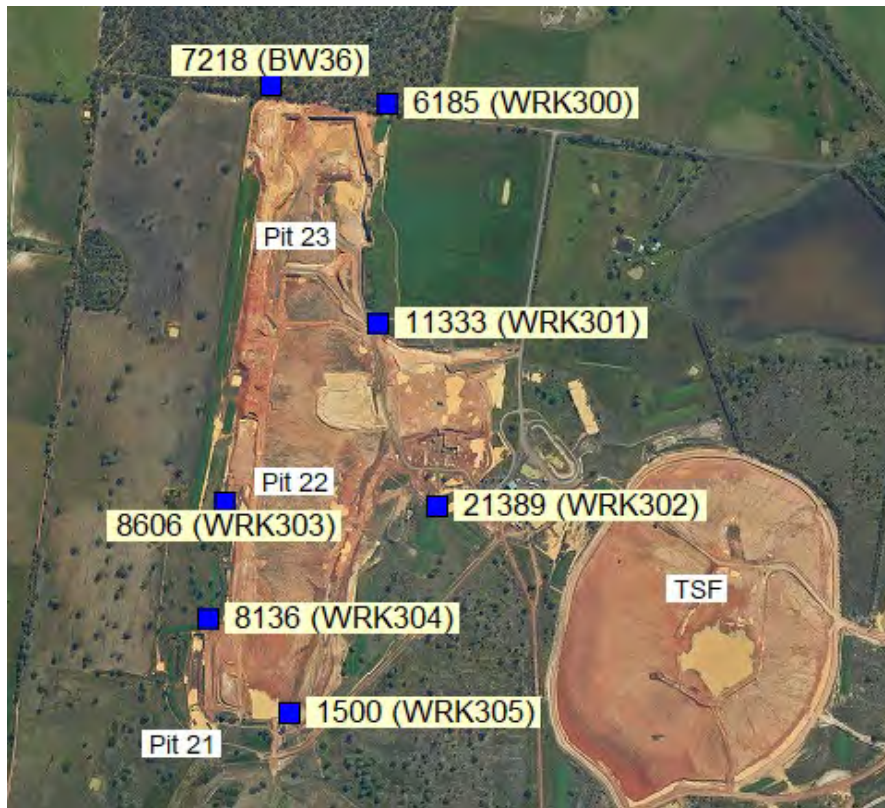
Figure 3.3 Locations and latest (2018) electrical conductivity measurements ($\mu\text{S}/\text{cm}$) of bores surrounding Pit 23

- the highest electrical conductivity observed in the bores surrounding Pit 23 is seen in WRK302, which had a reading of 21,000 $\mu\text{S}/\text{cm}$ in August 2018;

- BW28A is located outside of the Pit 23 groundwater flow path but has consistently exhibited electrical conductivity levels of more than 15,000 $\mu\text{S}/\text{cm}$ from 2016 onward. Similarly, WRK301 is upstream of the flow path and has shown consistently elevated levels of more than 8,500 $\mu\text{S}/\text{cm}$. The electrical conductivity levels seen in these bores are higher than those in the flow path; and

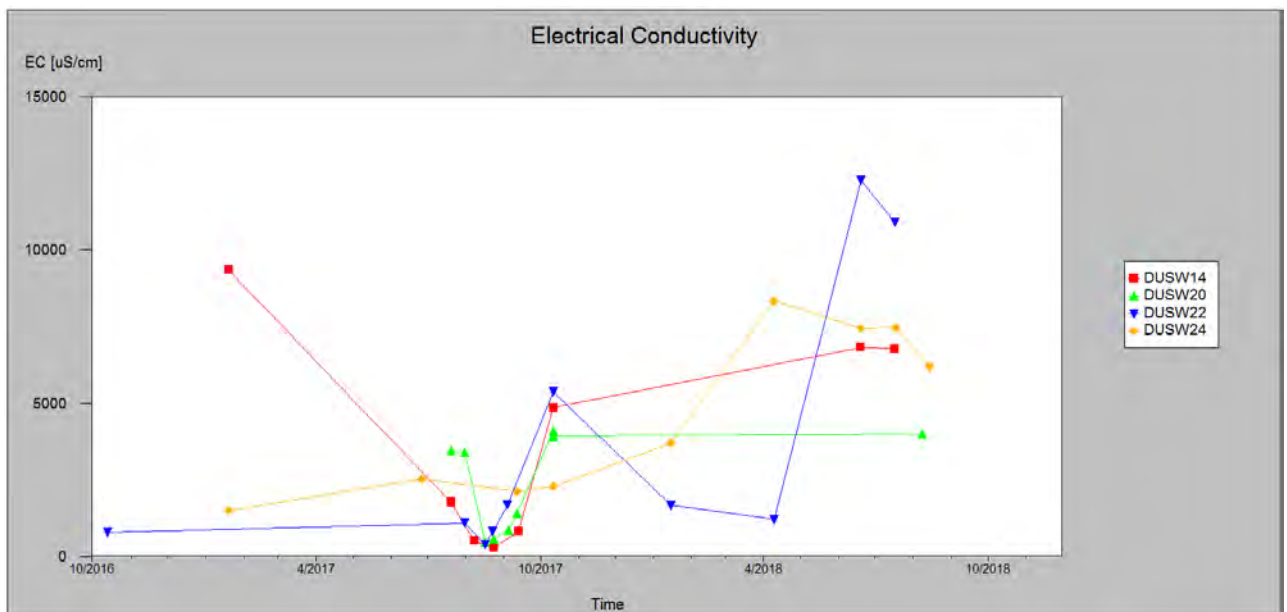
Figure 3.7 Comparison of electrical conductivity measurements ($\mu\text{S/cm}$) from groundwater-influenced surface water sites. DUSW14, DUSW20, DUSW22 and DUSW24 correspond to Costello’s Creek, Northern Drainage Line, Shaw’s Gully Creek and McGlashin Swamp respectively.

- electrical conductivity measurements at McGlashin Swamp follow similar trends to other groundwater-influenced surface water locations. Each of the locations show a decrease in conductivity toward the end of 2017, before increasing in 2018, suggesting that this trend could be due to environmental factors and/or other related geochemical phenomena (see Section 4.2).

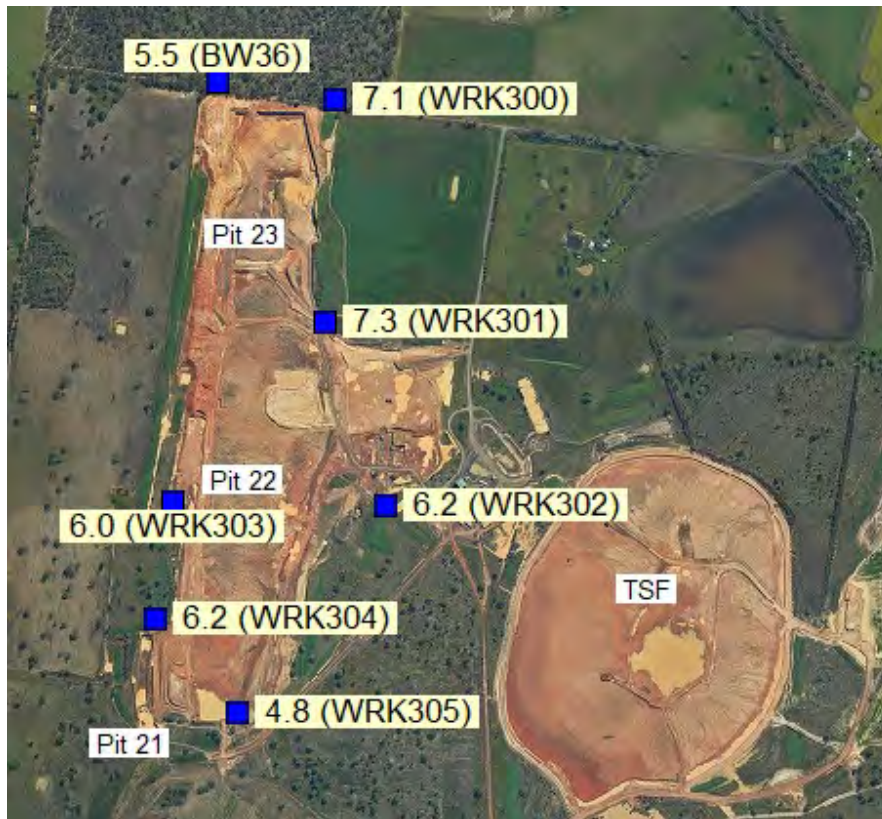
Figure 3.8 Locations and latest (2018) pH measurements of bores surrounding Pit 23

- the highest pH reading observed in the bores surrounding Pit 23 between 2014 and 2018 was 7.7 in WRK301. This reading is lower than all of the readings taken at McGlashin Swamp, which range from 8.6 to 10.4;

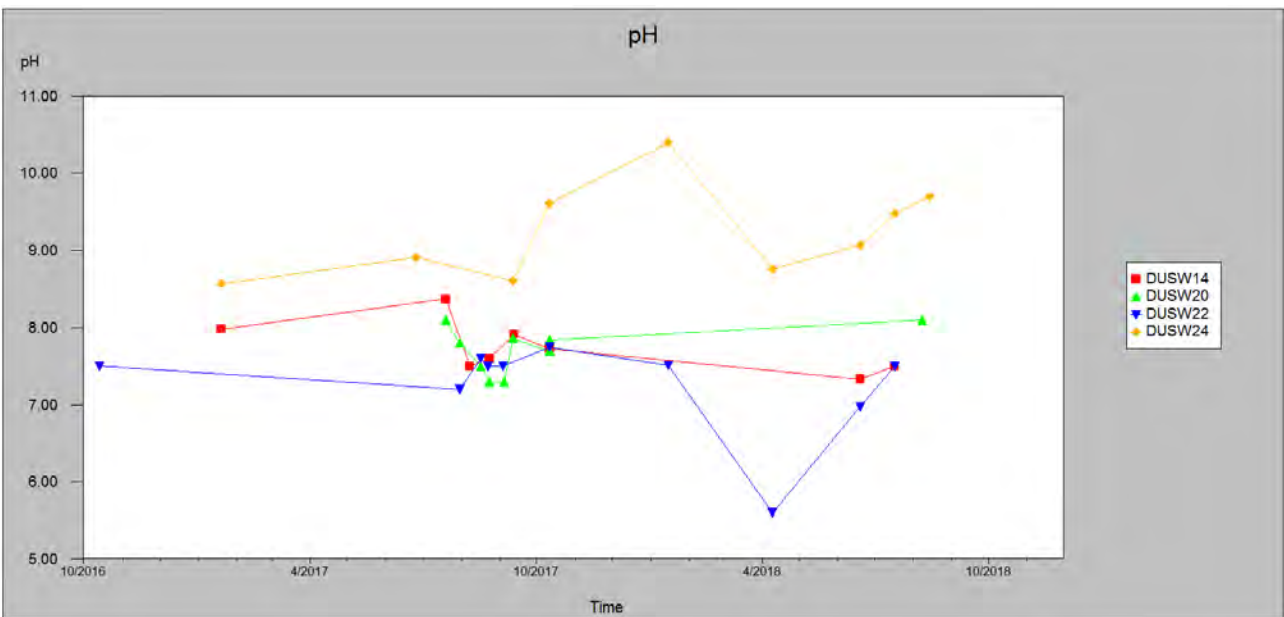
Figure 3.12 Comparison of pH measurements from groundwater-influenced surface water sites. DUSW14, DUSW20, DUSW22 and DUSW24 correspond to Costello’s Creek, Northern Drainage Line, Shaw’s Gully Creek and McGlashin Swamp respectively.

- pH measurements at McGlashin Swamp have been consistently higher than other groundwater-influenced surface water bodies since monitoring began in 2017, and unlike the other bodies, the pH is trending upward. This suggests that a process is occurring exclusively in McGlashin Swamp (and possibly at other swamps located outside of the study area) which is leading to alkalinisation of the system; and

- other groundwater-influenced surface water bodies including Costello's Creek, the Northern Drainage Line and Shaw's Gully, exhibit pH levels averaging around 7.5, which matches the groundwater pH levels observed in BW28A and the bores surrounding Pit 23.

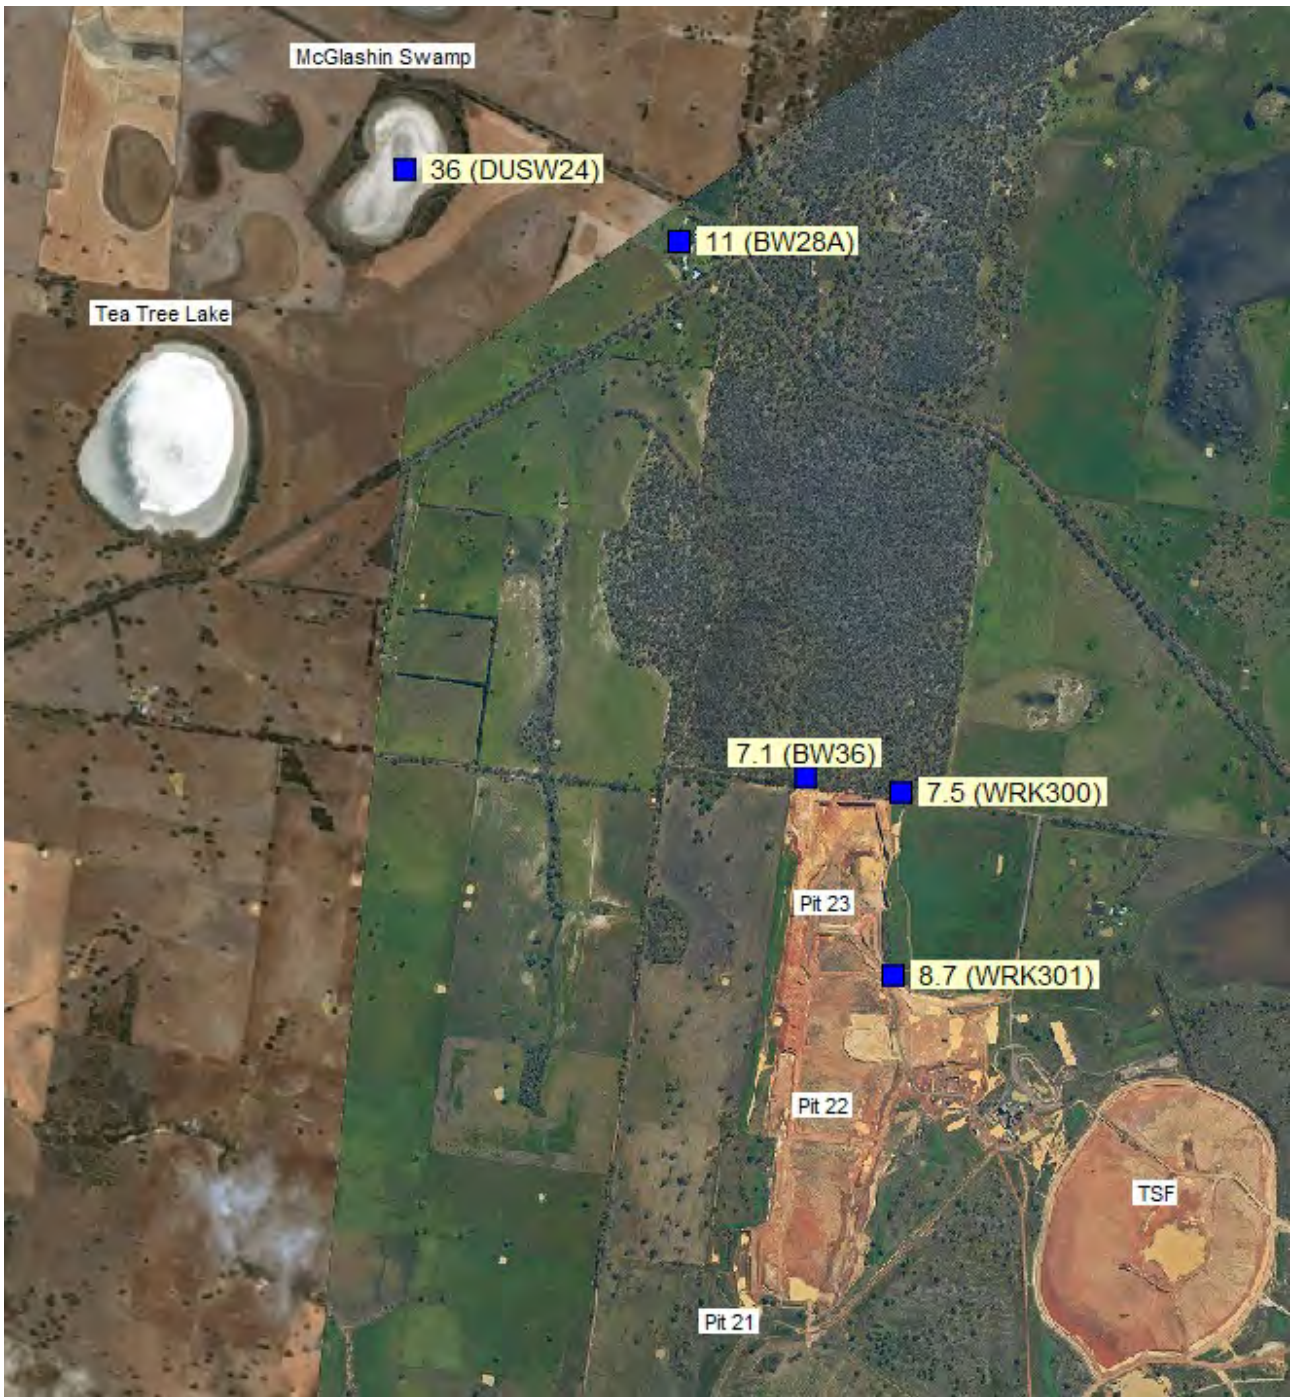
Figure 3.15 Locations and latest (2018) $\text{Cl}:\text{SO}_4$ measurements of bores in or near the groundwater flow path from Pit 23 and at McGlashin Swamp (DUSW24)

- Cl:SO₄ measurements at McGlashin Swamp are much higher than those seen in the Pit 23 groundwater flow path or in BW28A, which is outside of the flow path. The high Cl:SO₄ values observed suggest that McGlashin Swamp has not been strongly affected by groundwater as this would lead to much lower Cl:SO₄ levels, as seen in the other groundwater-influenced surface water bodies;

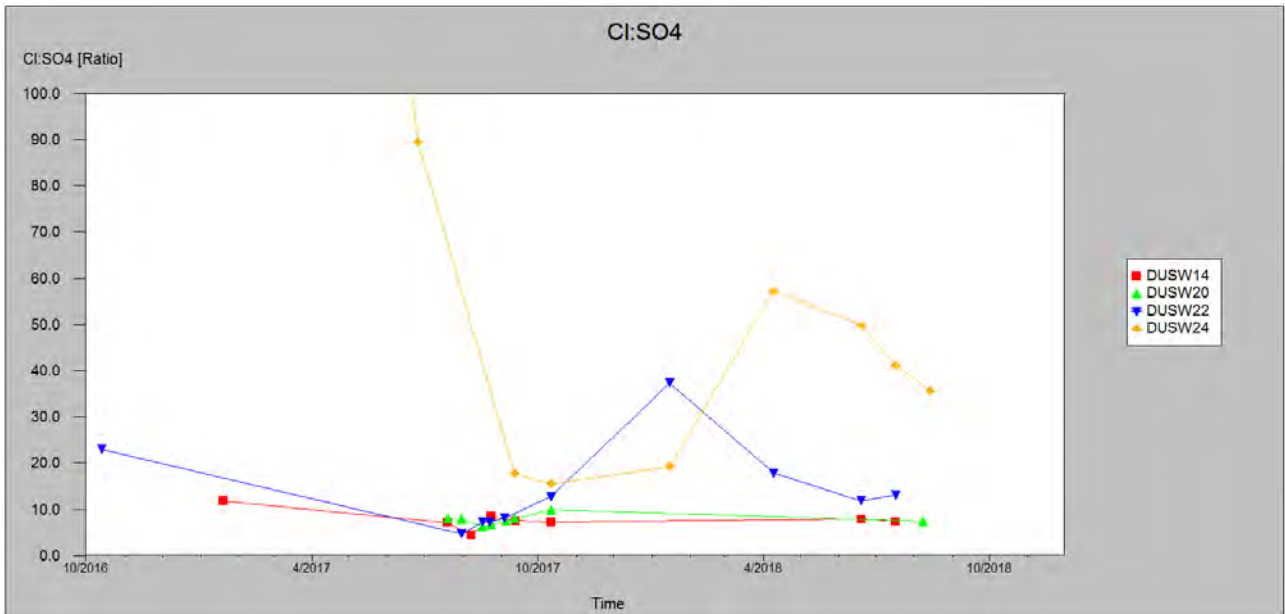
Figure 3.18 Comparison of Cl:SO₄ measurements from groundwater-influenced surface water sites. DUSW14, DUSW20, DUSW22 and DUSW24 correspond to Costello’s Creek, Northern Drainage Line, Shaw’s Gully Creek and McGlashin Swamp respectively.

- Cl:SO₄ measurements at McGlashin Swamp have been consistently higher than other groundwater-influenced surface water bodies since monitoring began in 2017. The high Cl:SO₄ is due to lower sulphate concentrations at McGlashin Swamp (1–72 mg/L) than other locations, suggesting that the water signature is not strongly affected by groundwater mixing which shows sulphate concentrations of 290–940 mg/L in the Pit 23 groundwater flow path; and

- Costello's Creek and the Northern Drainage Line exhibit much lower Cl:SO₄ levels around 10, which is similar to what is observed in groundwater.

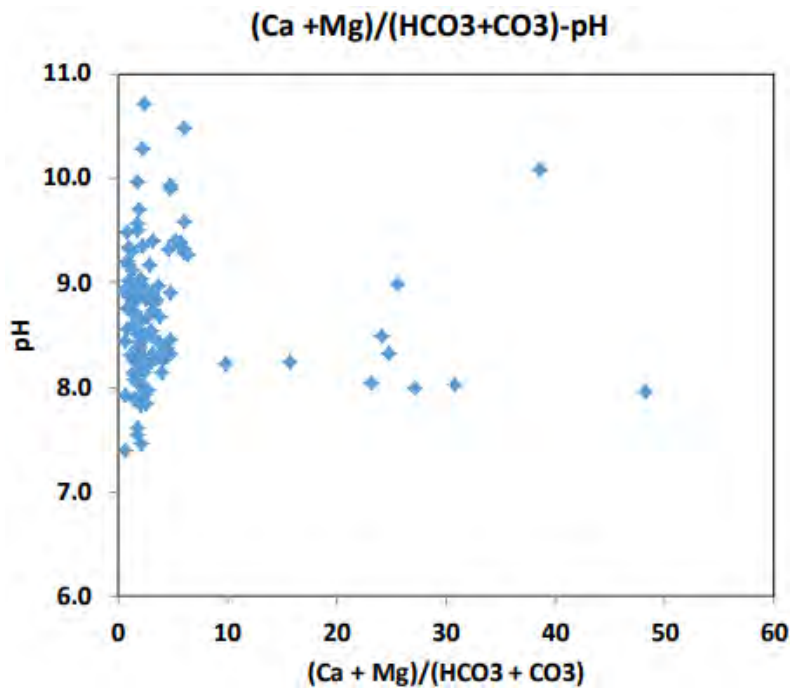
Figure 4.4 Sum of calcium and magnesium divided by the sum of carbonate and bicarbonate concentrations (meq/L) versus pH in wetlands (Reid & Mosley 2015)

Figure 4.4 shows that ratios lower than approximately 10 will result in pH levels ranging roughly between 7.5 and 11.0, with most being in the 8.0 to 9.0 range. Table 4.2 shows the ratios calculated when considering McGlashin Swamp data collected in 2017 with ratios range from 0.64 to 2.97. This is considered very low, indicating that McGlashin Swamp would be expected to increase in pH caused by evapoconcentration.

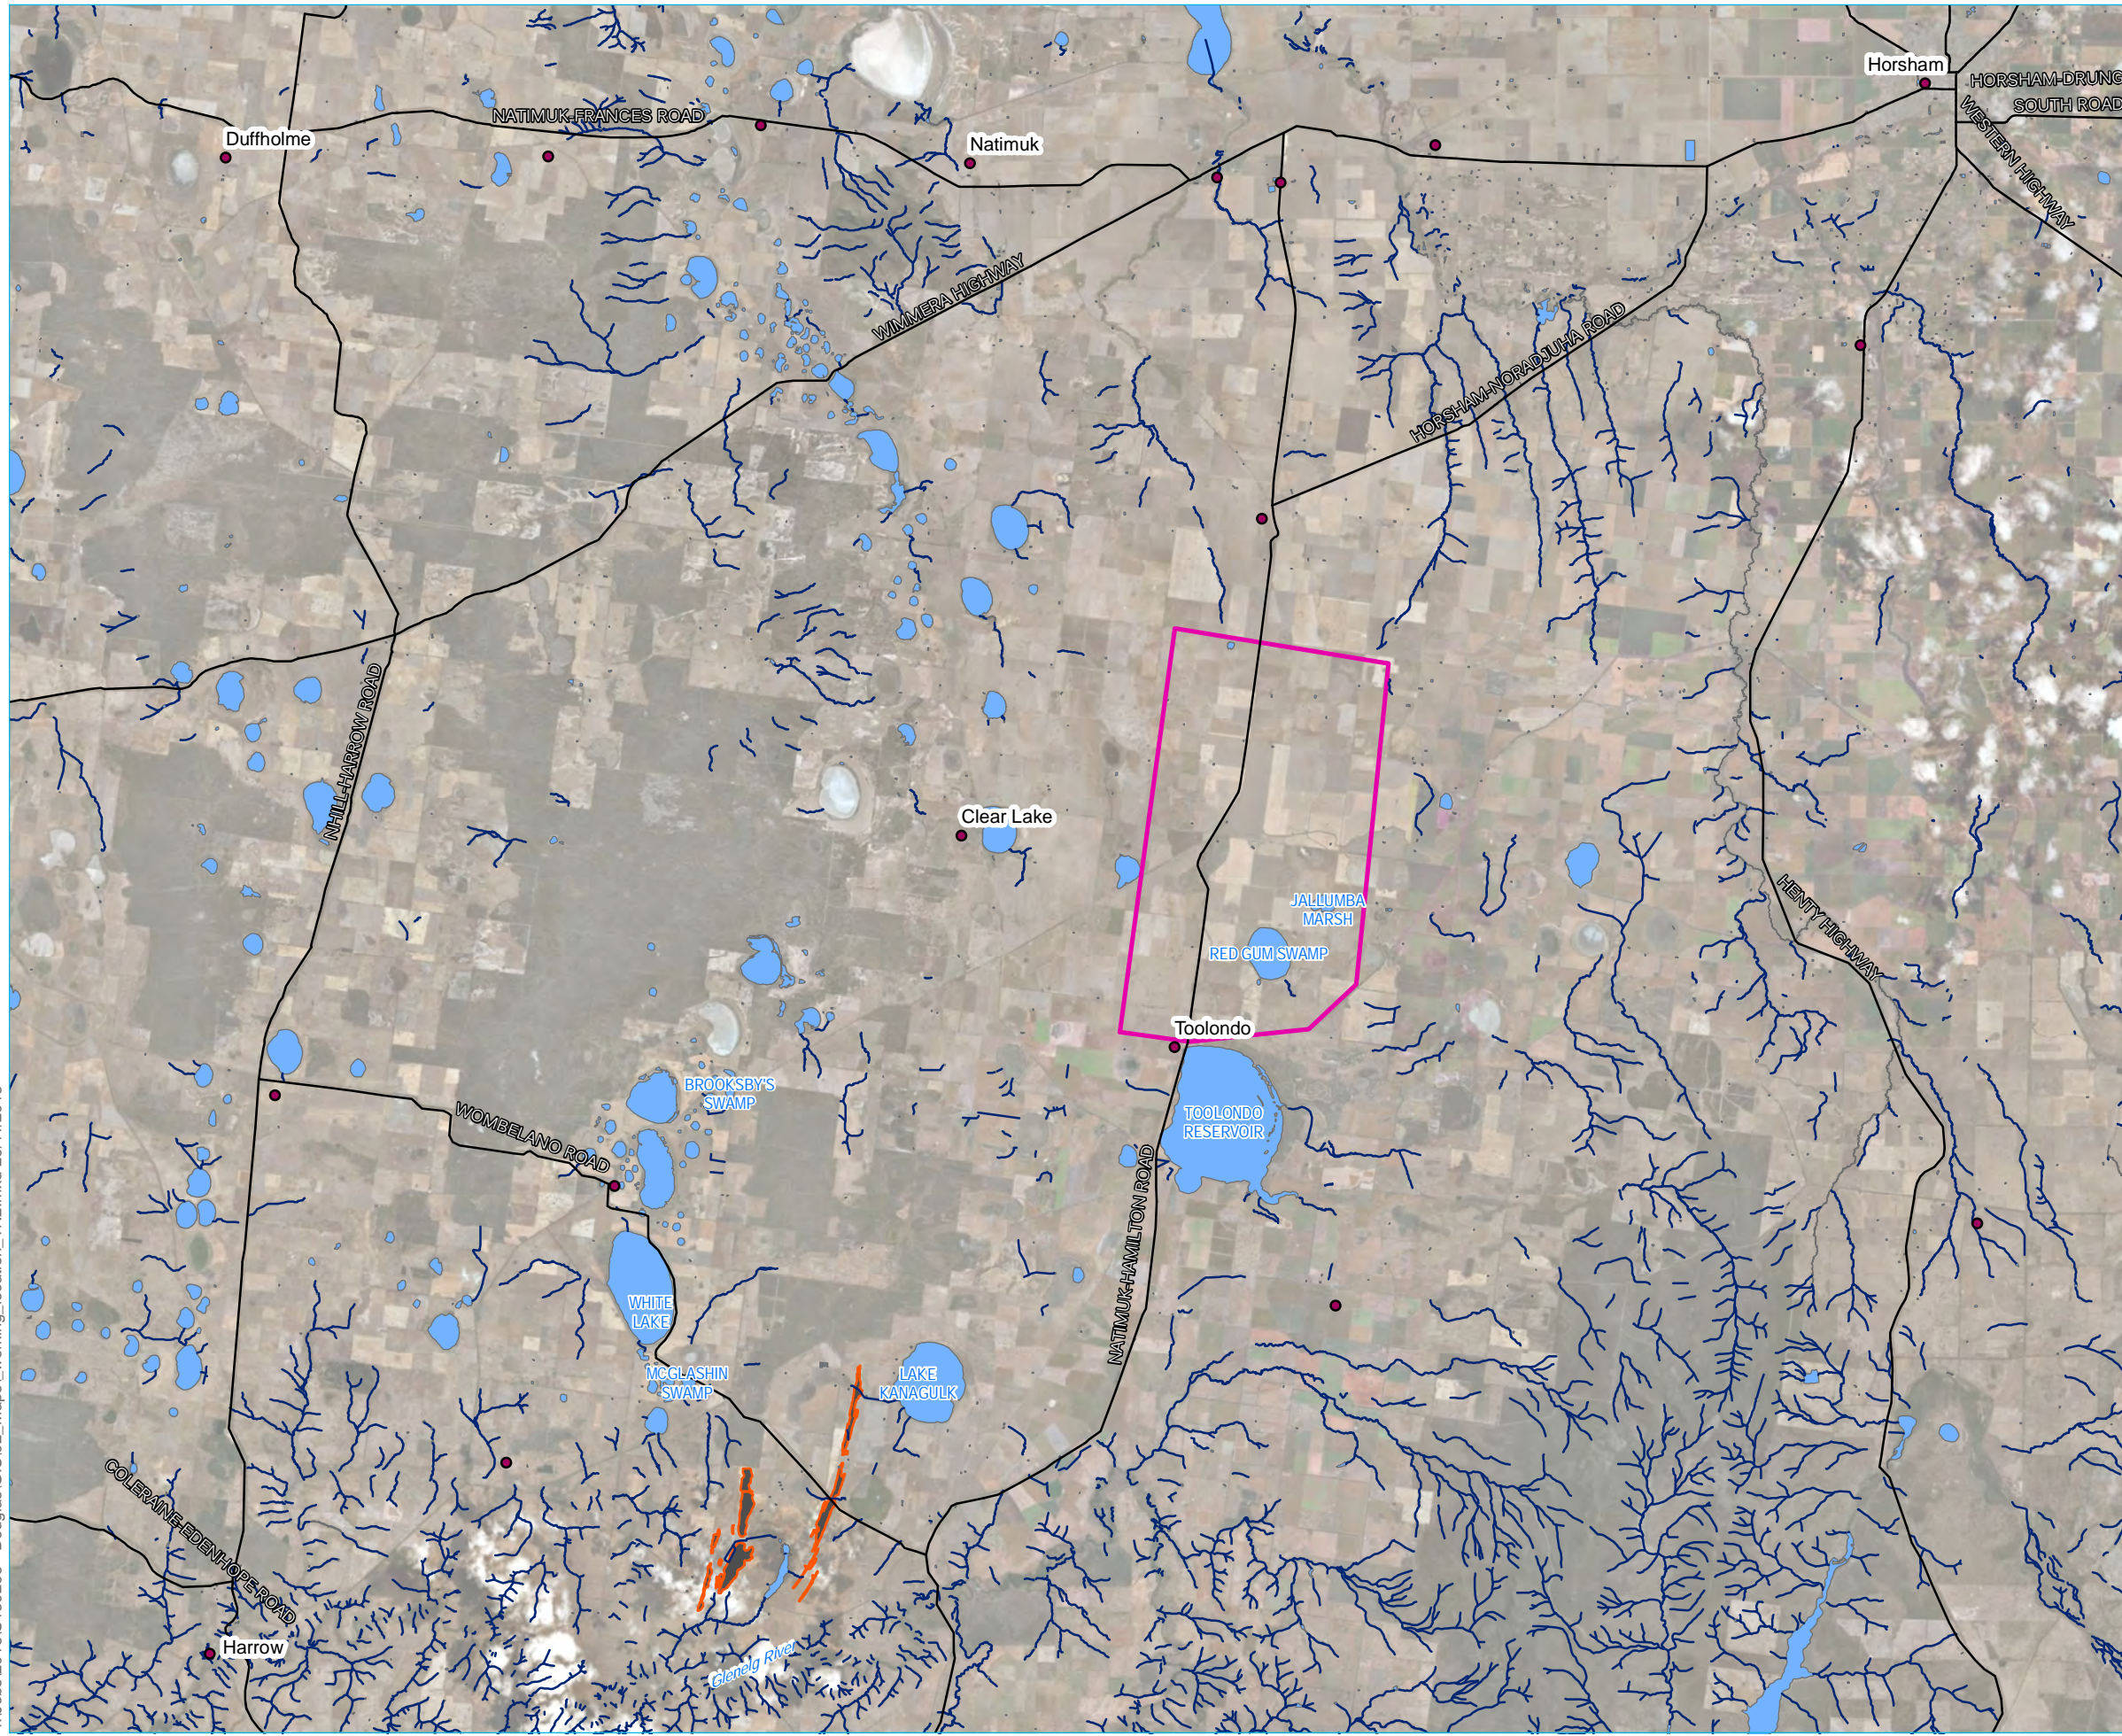
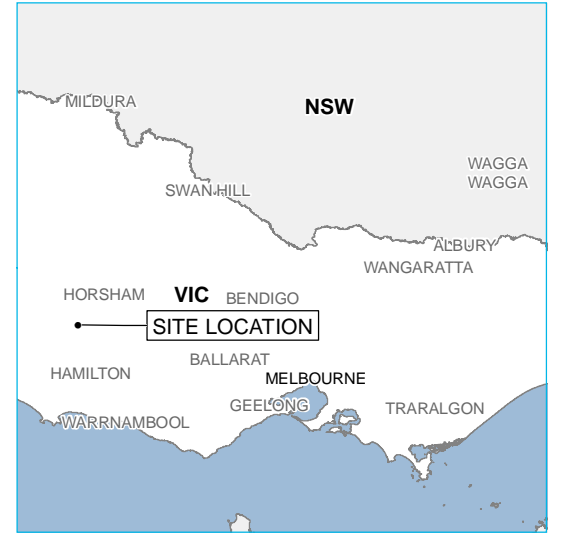
Figure 4.5
WIM100 site location and
surface water monitoring

- KEY**
- Towns
 - Roads
 - Watercourses
 - Waterbodies
 - ▭ WIM100 site location
 - Douglas mine

To determine whether high pH levels are being recorded at other similar wetland/swamp environments in the region, Iluka supplied EMM with the baseline surface water monitoring data currently being collected to support Iluka's WIM100 Fine Minerals Project. Currently, two wetlands are being sampled as part of this project including Redgum Swamp and Jallumba Marsh. The location of these two wetlands in relation to McGlashin Swamp and the Douglas Mine is shown in Figure 4.5. The recorded pH values over the last three recordings for McGlashin Swamp, Redgum Swamp and Jallumba Marsh is shown in Figure 4.6. The following is observed:

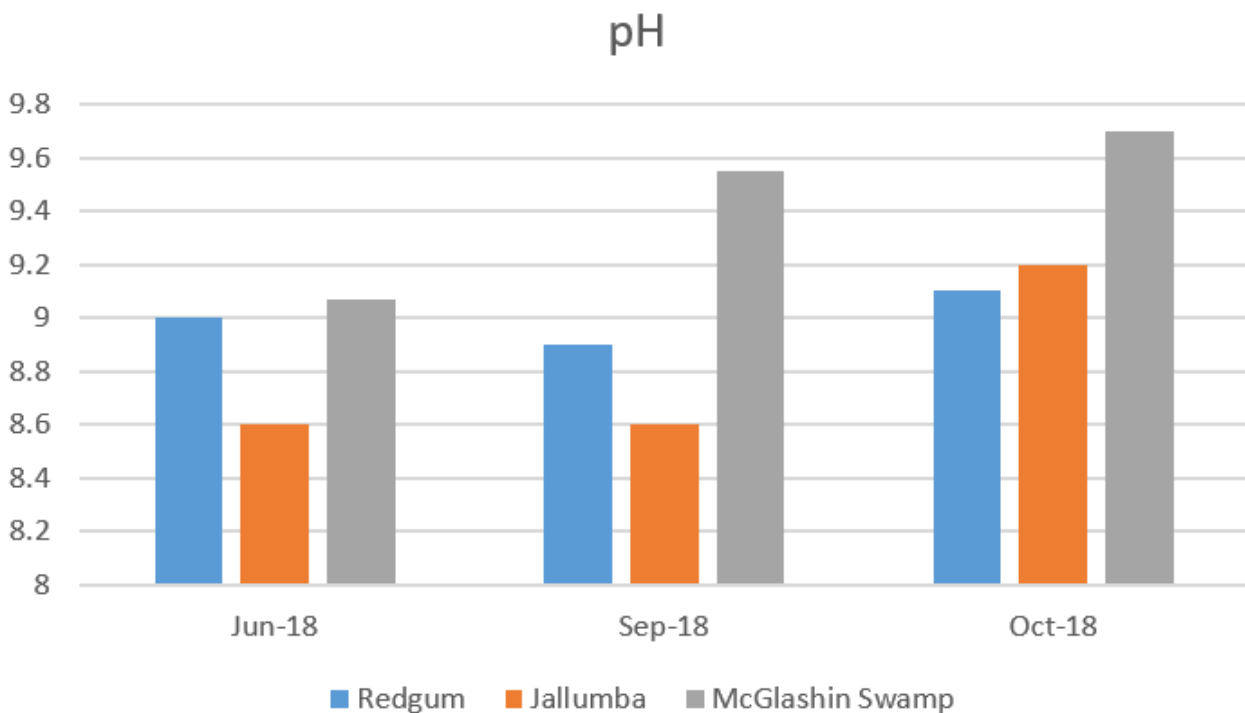
Figure 4.6 Recent pH recordings at McGlashin Swamp, Redgum Swamp and Jallumba Marsh.

- minimum pH recorded over the period was 8.6 across all sites;
- all surface water is alkaline;
- over the last two monitoring events, the Jallumba Marsh pH has increased dramatically (from September to October), similar to the increase seen at McGlashin between June and September; and
- it appears similar geochemical processes are occurring across numerous wetland/swamp environments in the region, although some variability is expected due to local geomorphic, hydrogeological and soil chemical variability.
