# Iluka Resources Limited

## *Audit of 2018 EMP and IMWP Annual Reports*

19121052-001-R-Rev0

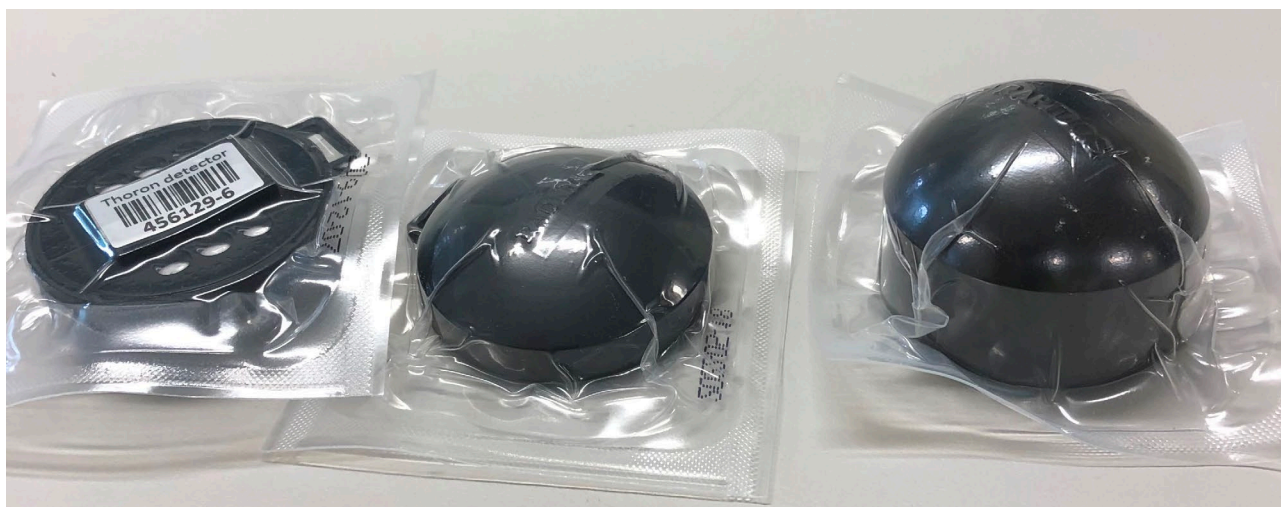
Figure 5: Radon and thoron detectors (left/middle: "Radtrak2", right: "RapiDOS HS")

Monitoring of radon concentrations in air is undertaken at four locations within and immediately adjacent to Pit 23 and at two residences east of Pit 23 (Chadwick's) and south of Pit 23 (Rises). Radon monitoring is undertaken using Landauer "Radtrak2" radon/thoron track etch detectors and the newer RapiDOS High Sensitivity ("RapiDOS HS") radon detectors (Figure 5).

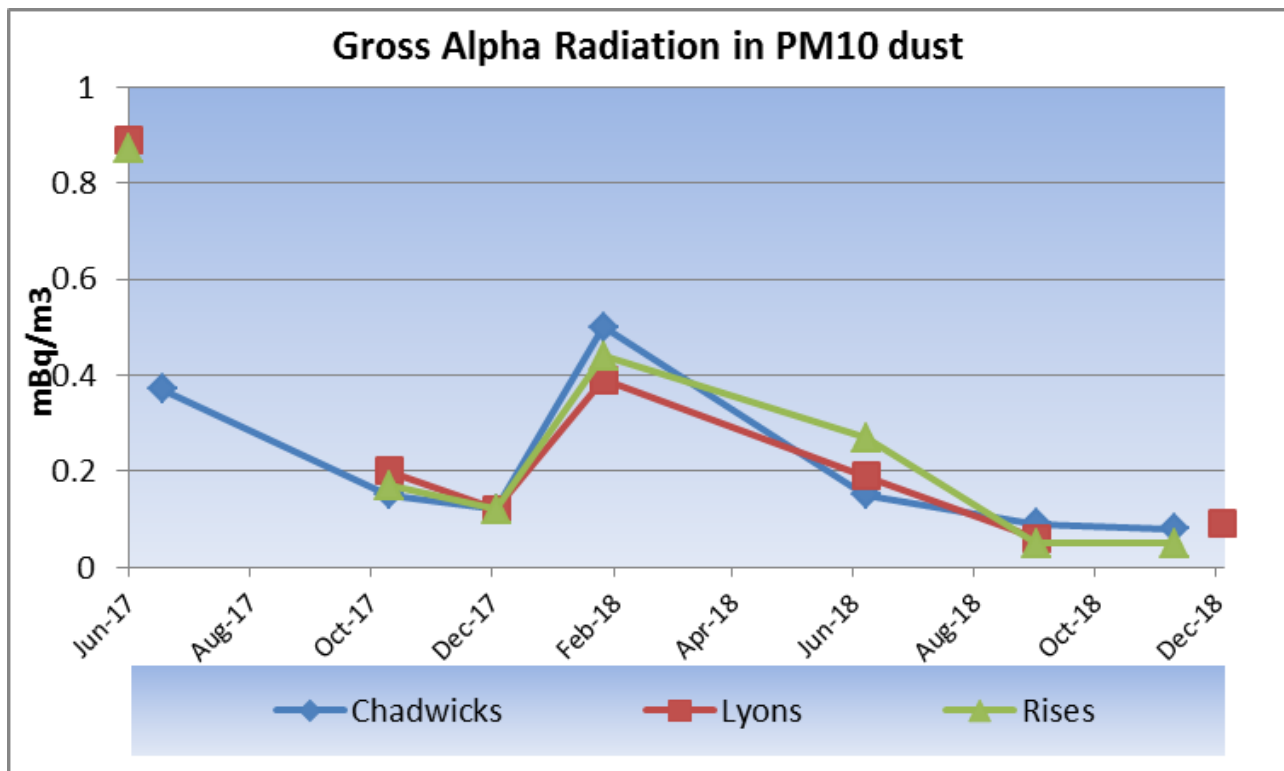
Figure 8: Gross Alpha Radiation in PM10 Dust

Location (Douglas)	Date	Sample No.	Run Time (Hrs)	Air Volume (m <sup>3</sup> )	Activity Conc (mBq/m <sup>3</sup> )
Chadwick’s	08/02/2018	C33	95:46	5756	0.50
Lyons	08/02/2018	C34	89:26	5441	0.39
Rises	08/02/2018	C35	89:26	6635	0.44
Chadwick’s	20/06/2018	QB48	95:46	6228	0.15
Lyons	20/06/2018	QB47	95:46	6198	0.19
Rises	20/06/2018	QB46	95:46	5966	0.27
Chadwick’s	14/09/2018	GFG45	95:46	6088	0.09
Lyons	14/09/2018	GFG44	95:46	7032	0.06
Rises	14/09/2018	GFG46	95:46	5325	0.05
Chadwick’s	23/11/2018	GHI27	95:46	5932	0.08
Rises	23/11/2018	GHI28	95:46	5932	0.05
Lyons	17/12/2018	GHI38	95:45	6818	0.09

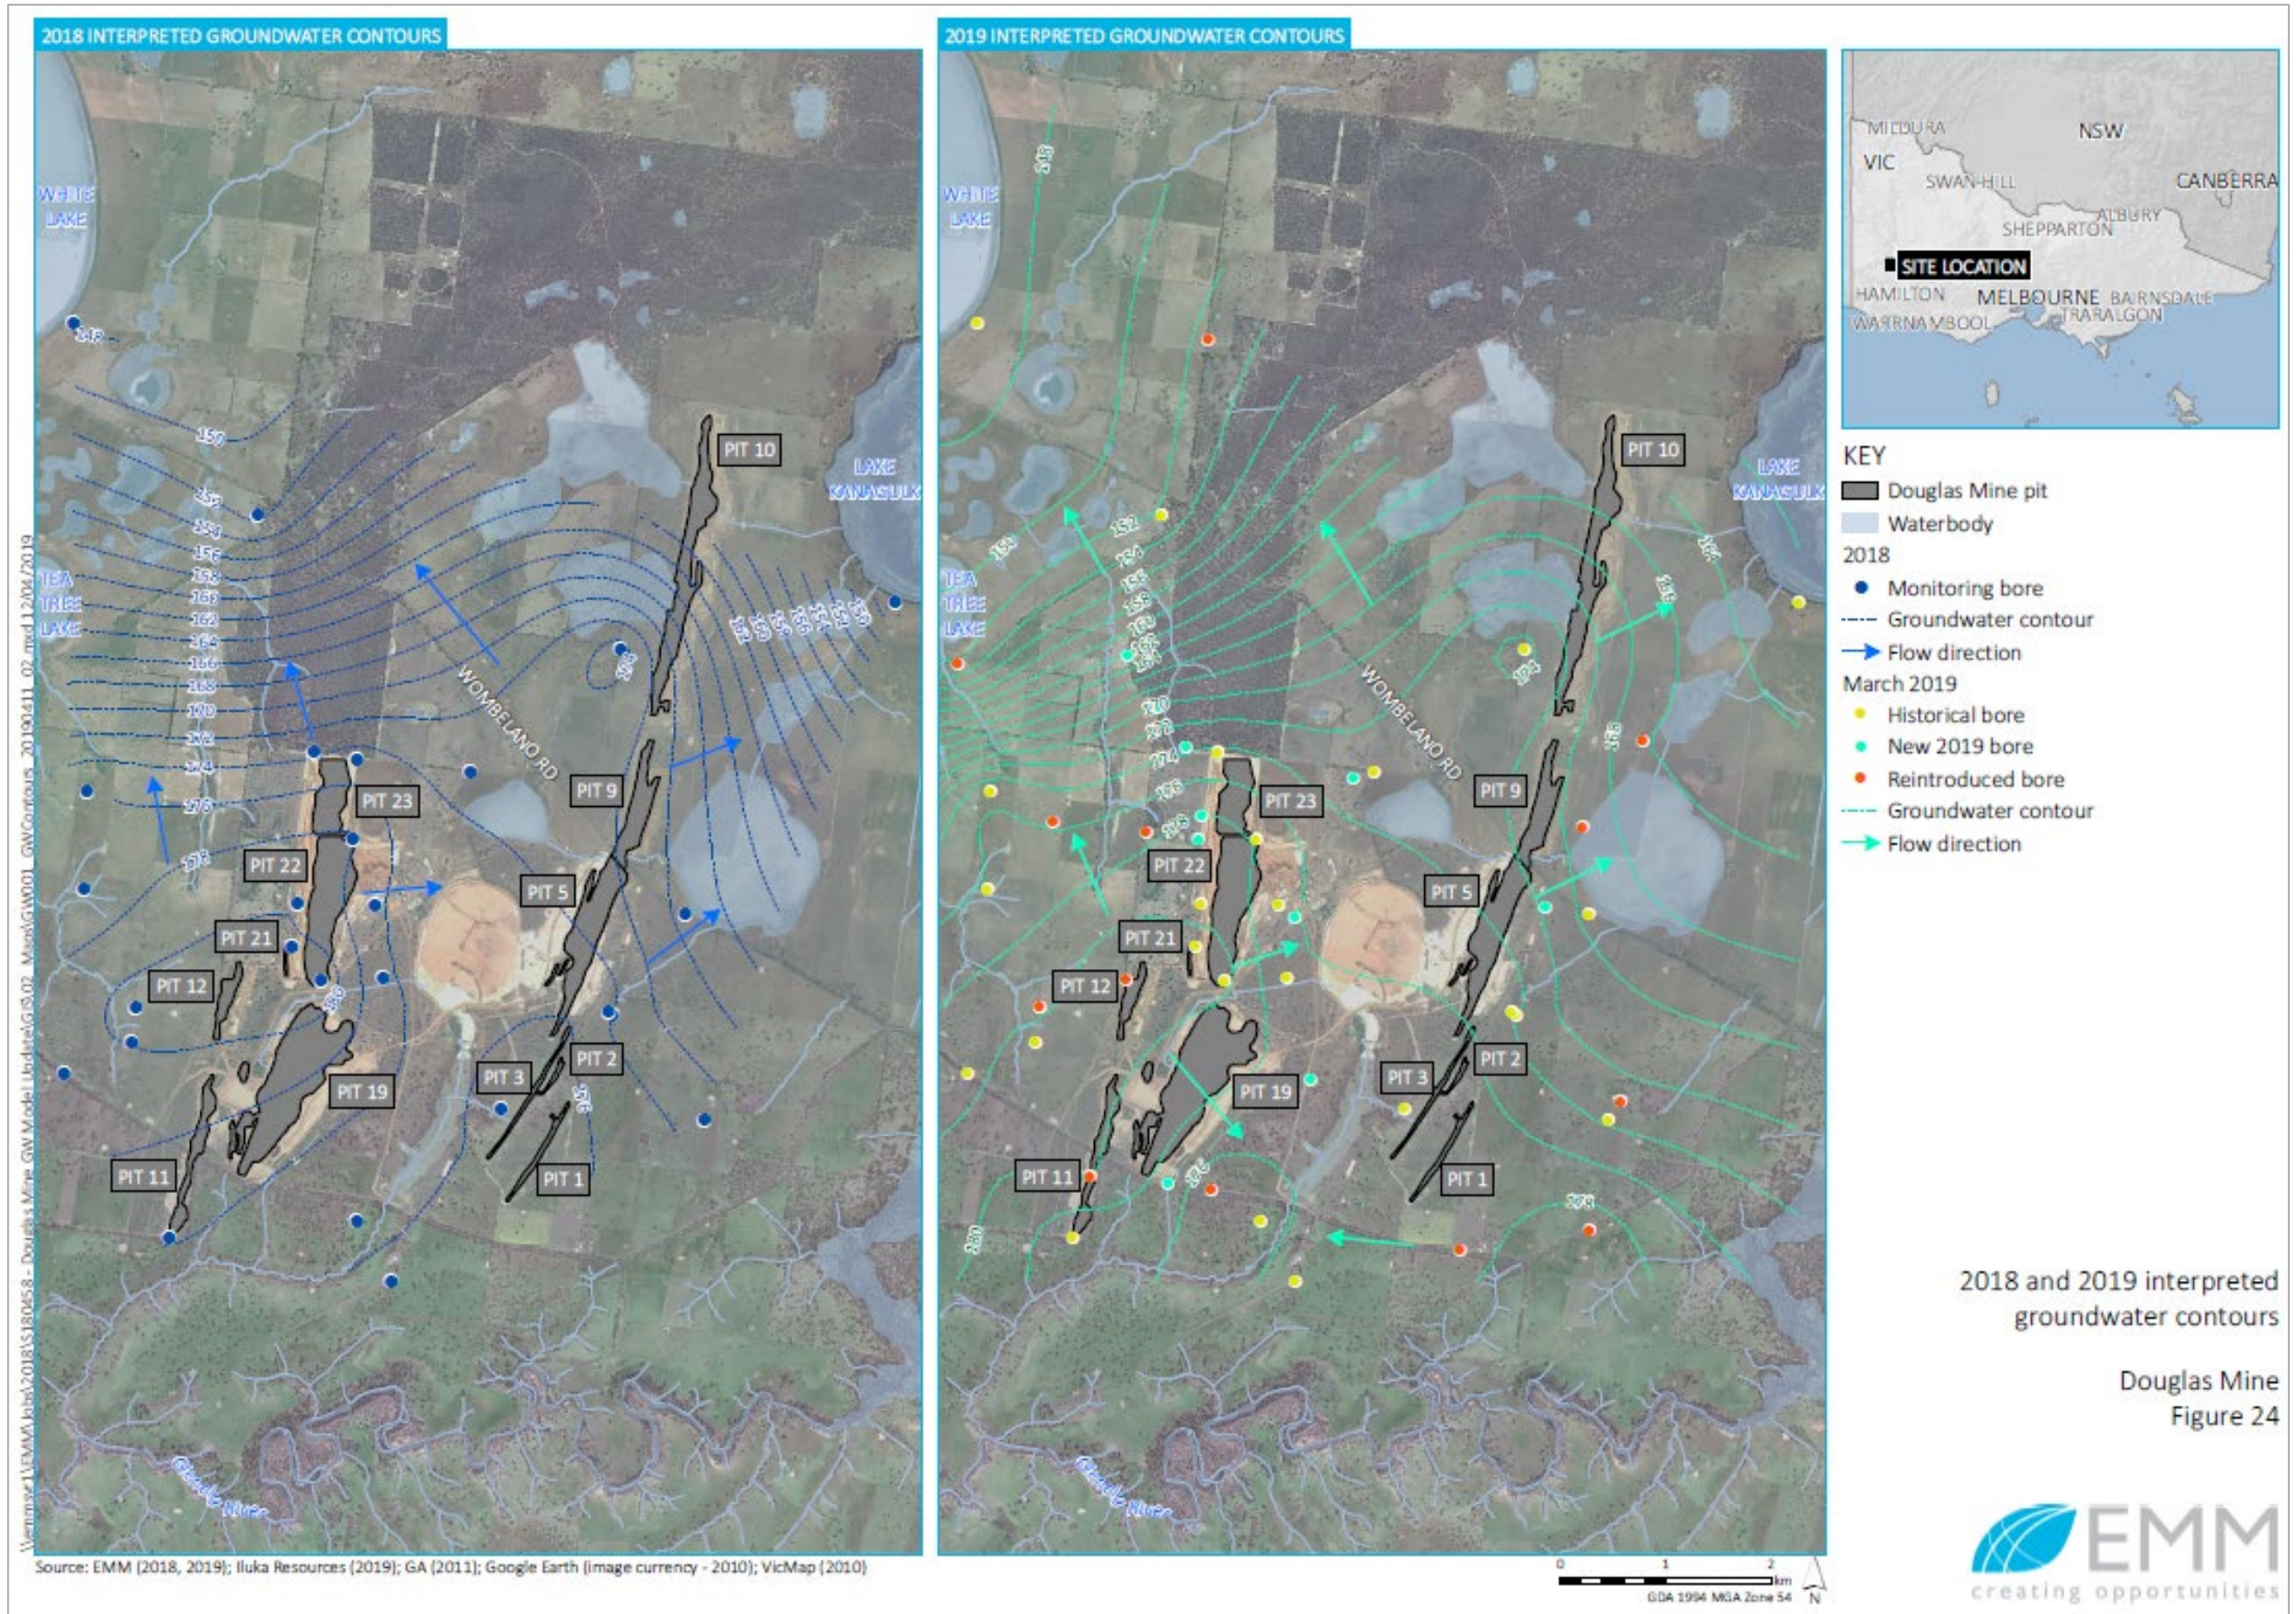
Figure 24: Douglas Groundwater contours and flow paths, June 2018 vs March 2019

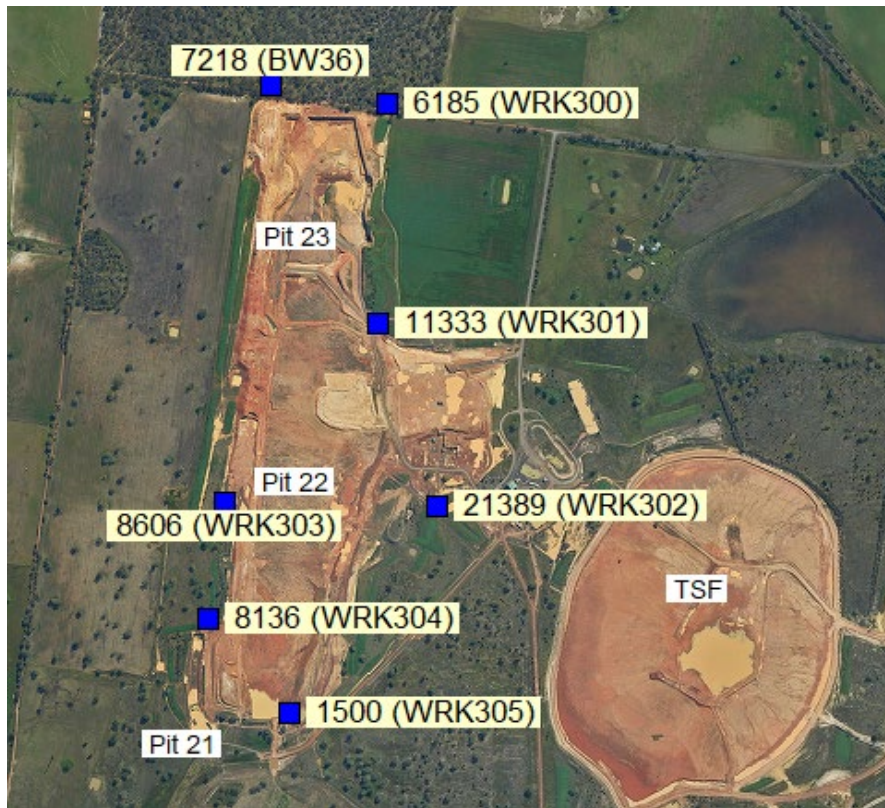
Figure 3.3 Locations and latest (2018) electrical conductivity measurements ( $\mu\text{S}/\text{cm}$ ) of bores surrounding Pit 23

Figure 3.3 and Figure 3.4 show the locations and historical electrical conductivity measurements of the bores immediately surrounding Pit 23, while Figure 3.5 and Figure 3.6 show the same information for bores that are on or near the flow path of groundwater originating from Pit 23. Figure 3.7 is a time-series plot which compares the electrical conductivity measurements observed at McGlashin Swamp to other groundwater-influenced surface water bodies across the Douglas mine. From these figures the following is observed:

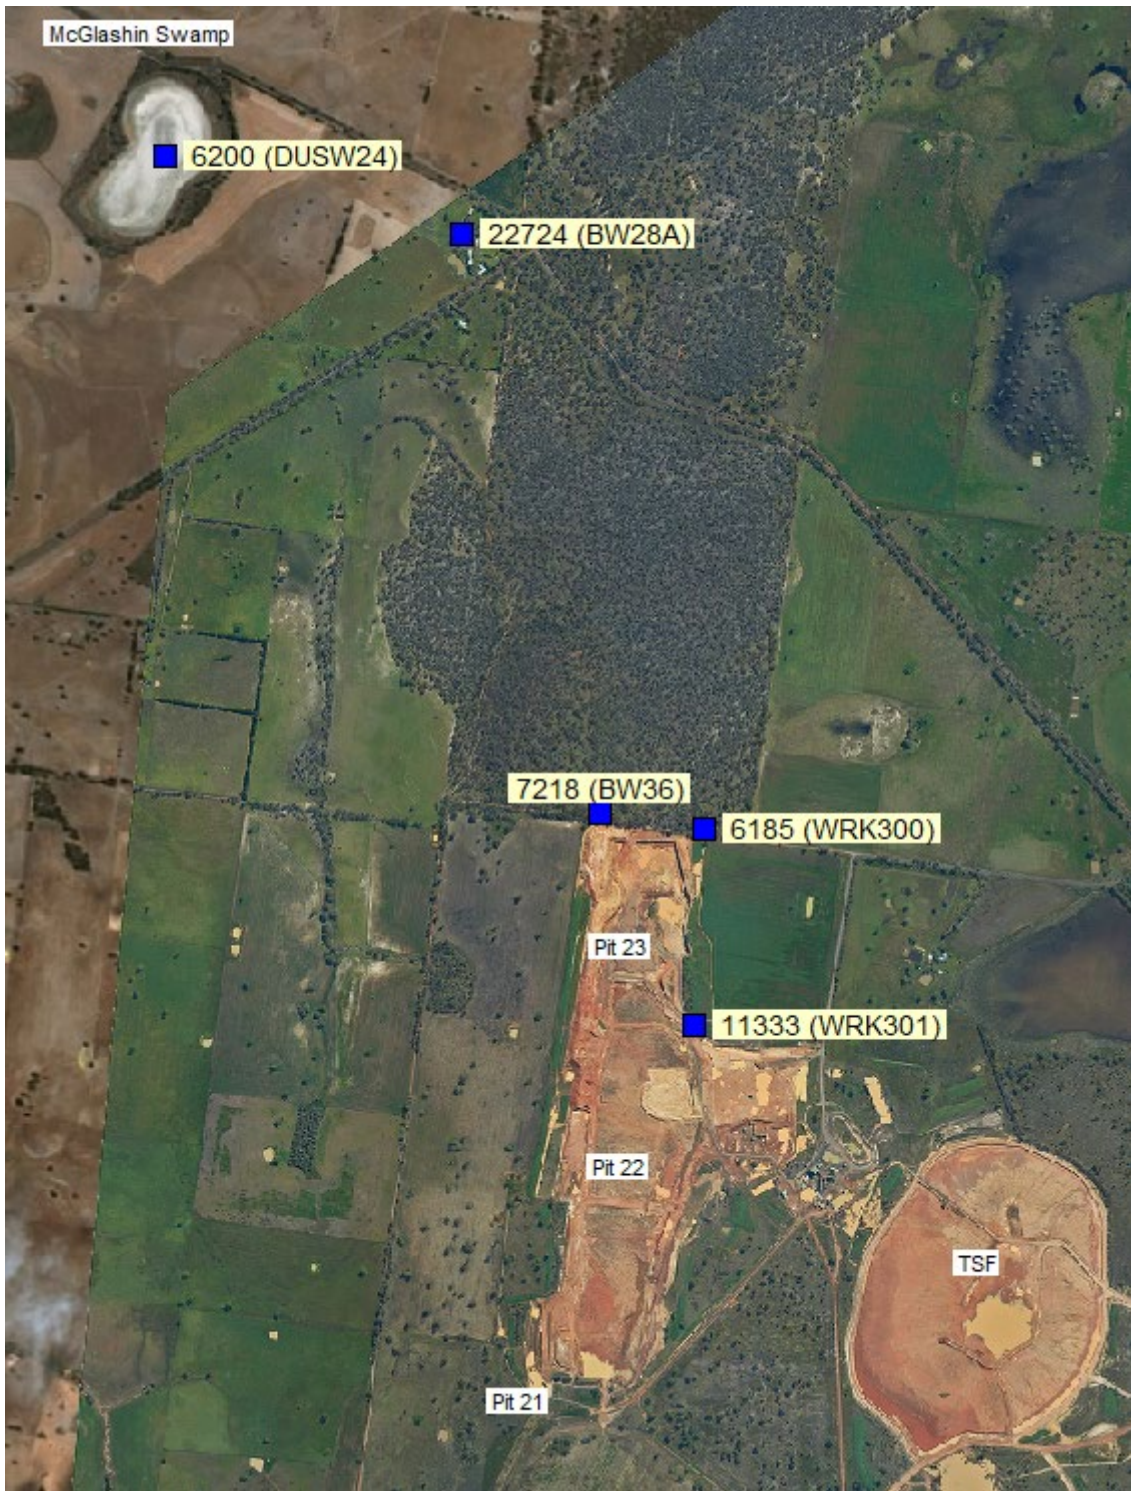
Figure 3.5 Locations and latest (2018) electrical conductivity measurements ( $\mu\text{S}/\text{cm}$ ) of bores in or near the groundwater flow path from Pit 23 and at McGlashin Swamp (DUSW24)

- BW28A is located outside of the Pit 23 groundwater flow path but has consistently exhibited electrical conductivity levels of more than 15,000  $\mu\text{S}/\text{cm}$  from 2016 onward. Similarly, WRK301 is upstream of the flow path and has shown consistently elevated levels of more than 8,500  $\mu\text{S}/\text{cm}$ . The electrical conductivity levels seen in these bores are higher than those in the flow path; and

- electrical conductivity measurements at McGlashin Swamp follow similar trends to other groundwater-influenced surface water locations. Each of the locations show a decrease in conductivity toward the end of 2017, before increasing in 2018, suggesting that this trend could be due to environmental factors and/or other related geochemical phenomena (see Section 4.2).

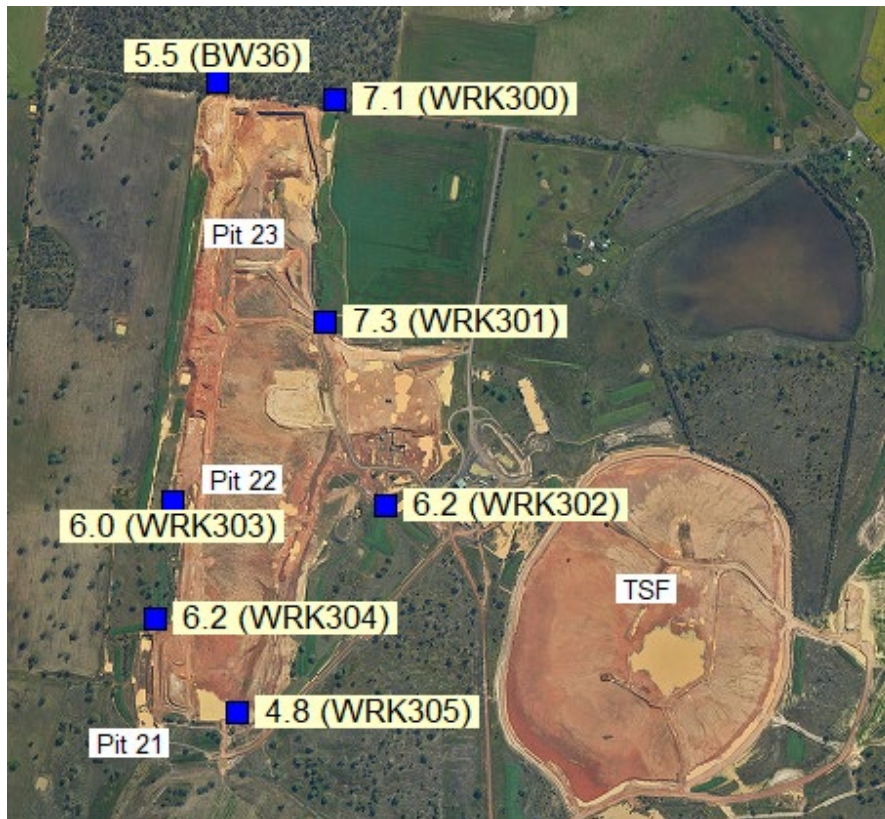
Figure 3.8 Locations and latest (2018) pH measurements of bores surrounding Pit 23

Figure 3.8 and Figure 3.9 show the locations and historical pH measurements of the bores immediately surrounding Pit 23, while Figure 3.10 and Figure 3.11 show the same information for bores that are in or near the flow path of groundwater from Pit 23. Figure 3.12 is a time-series plot which compares the pH measurements observed at McGlashin Swamp to other groundwater-influenced surface water bodies across the Douglas mine. From these figures the following is observed:

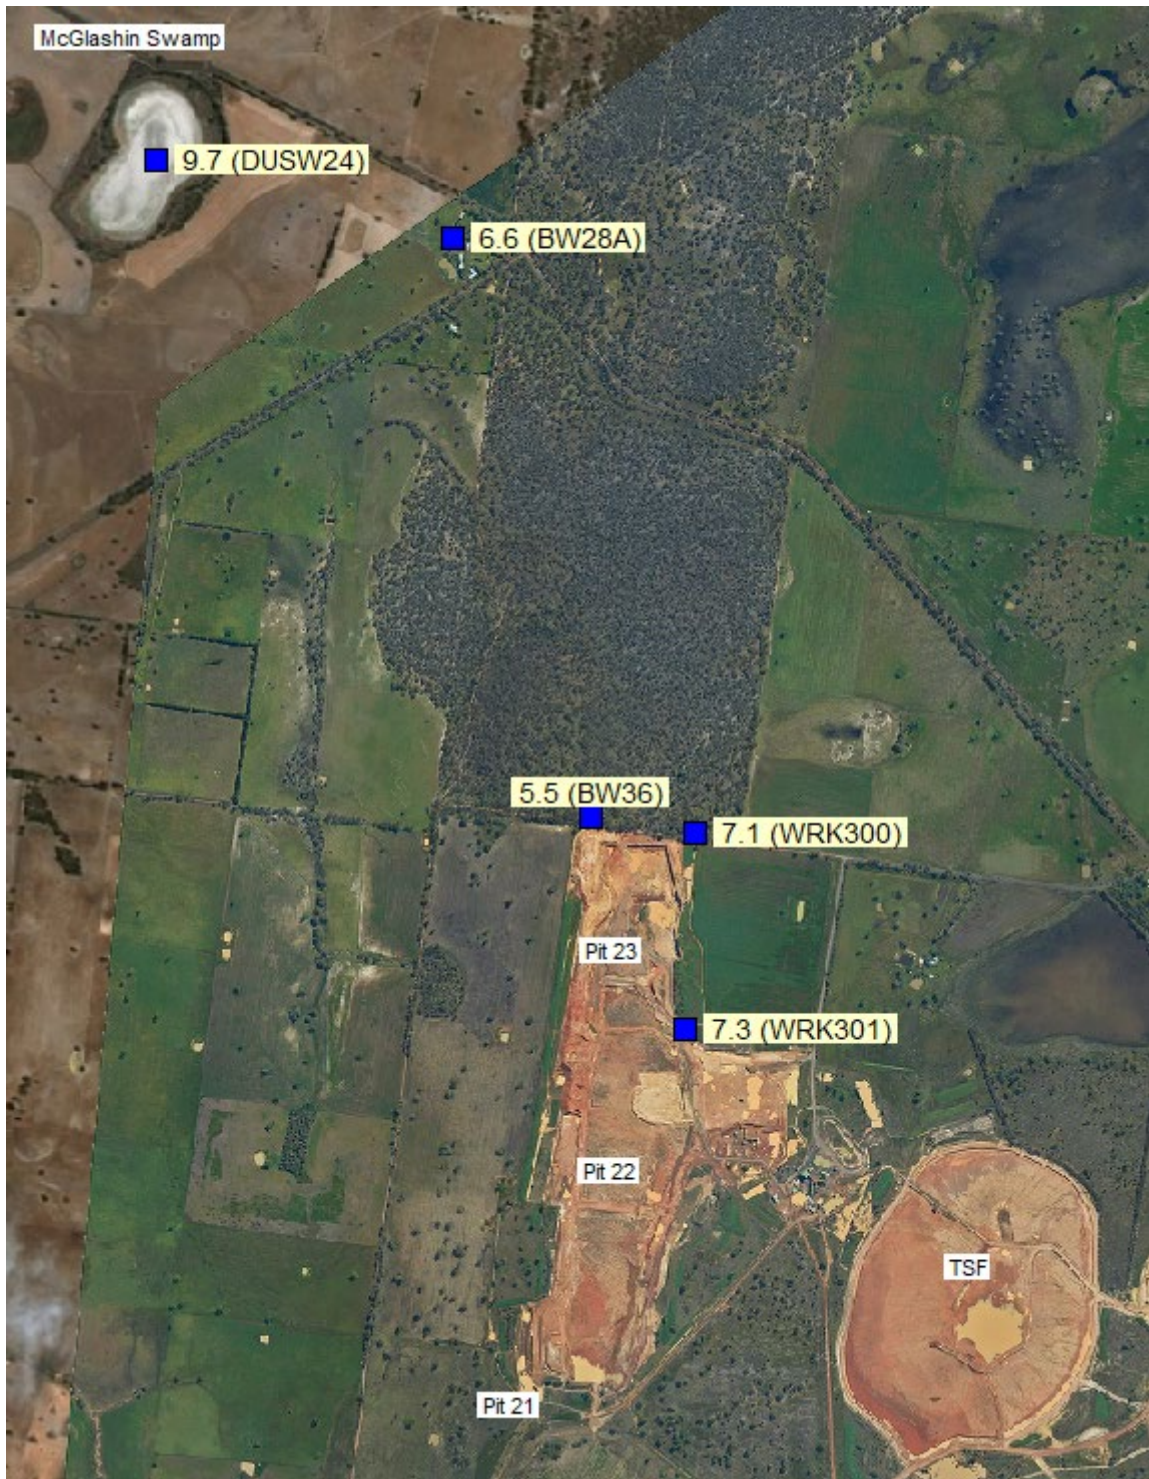
**Figure 3.10** Locations and latest (2018) pH measurements of bores in or near the groundwater flow path from Pit 23 and at McGlashin Swamp (DUSW24)

- pH measurements at McGlashin Swamp have been consistently higher than other groundwater-influenced surface water bodies since monitoring began in 2017, and unlike the other bodies, the pH is trending upward. This suggests that a process is occurring exclusively in McGlashin Swamp (and possibly at other swamps located outside of the study area) which is leading to alkalinisation of the system; and

- other groundwater-influenced surface water bodies including Costello's Creek, the Northern Drainage Line and Shaw's Gully, exhibit pH levels averaging around 7.5, which matches the groundwater pH levels observed in BW28A and the bores surrounding Pit 23.

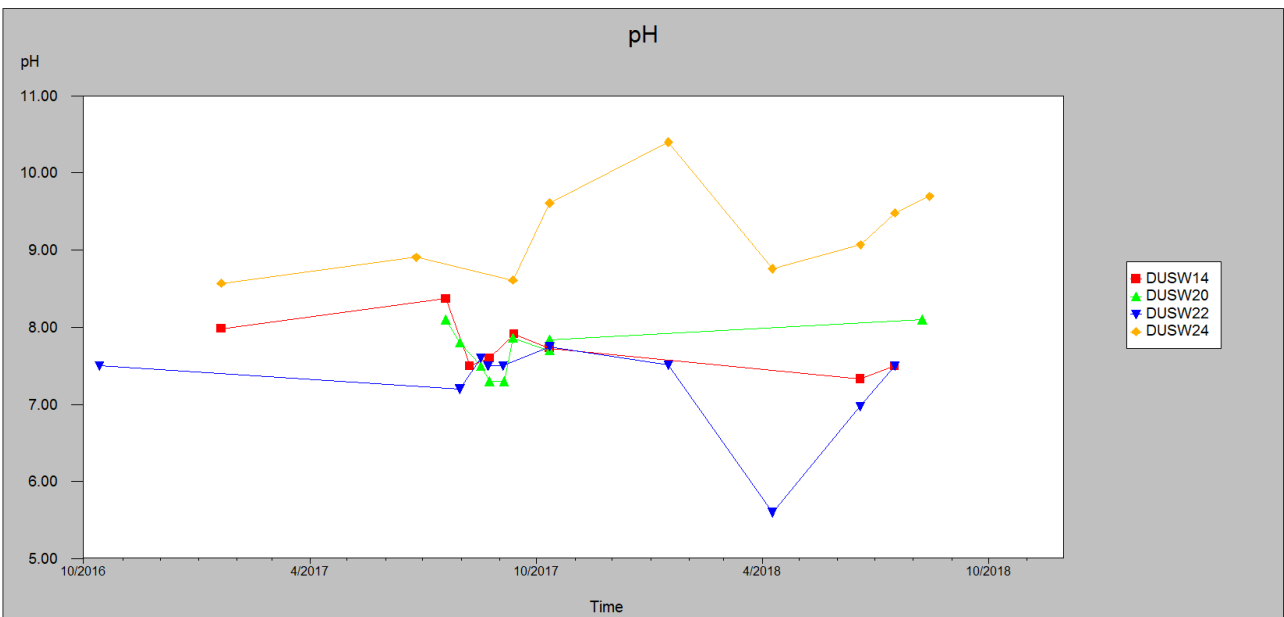
**Figure 3.12** Comparison of pH measurements from groundwater-influenced surface water sites. DUSW14, DUSW20, DUSW22 and DUSW24 correspond to Costello's Creek, Northern Drainage Line, Shaw's Gully Creek and McGlashin Swamp respectively.

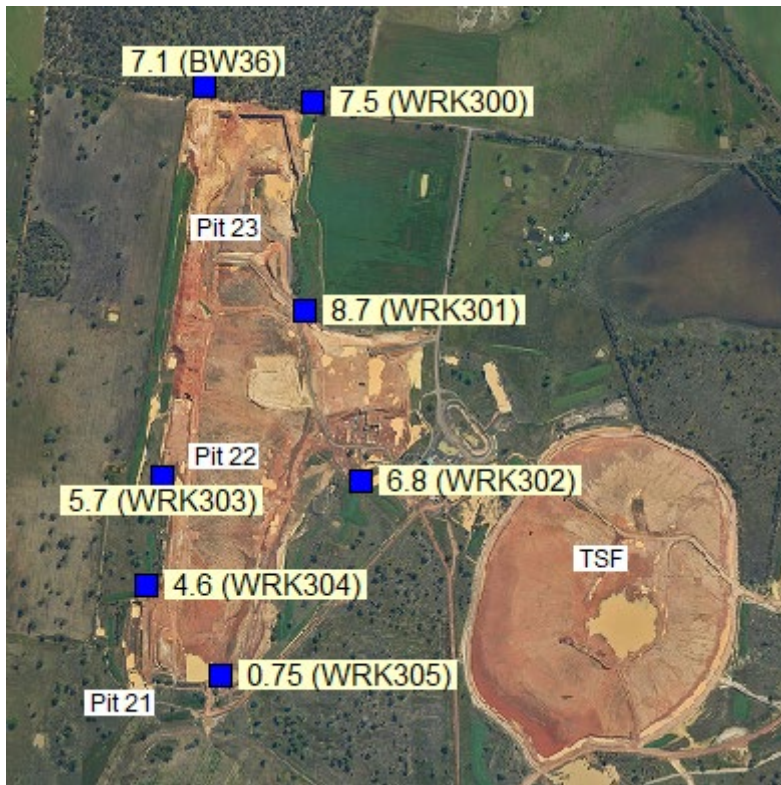
Figure 3.13 Locations and latest (2018) Cl:SO<sub>4</sub> measurements of bores surrounding Pit 23

Figure 3.13 and Figure 3.14 show the locations and historical Cl:SO<sub>4</sub> values of the bores immediately surrounding Pit 23, while Figure 3.15 and Figure 3.16 show the same information for bores that are in or near the flow path of groundwater from Pit 23. Figure 3.18 is a time-series plot which compares the Cl:SO<sub>4</sub> values observed at McGlashin Swamp to other groundwater-influenced surface water bodies across the Douglas mine. Figure 3.17 and Figure 3.19 compare the sulphate levels at McGlashin Swamp to nearby bores and surface water sites. From these figures the following is observed:

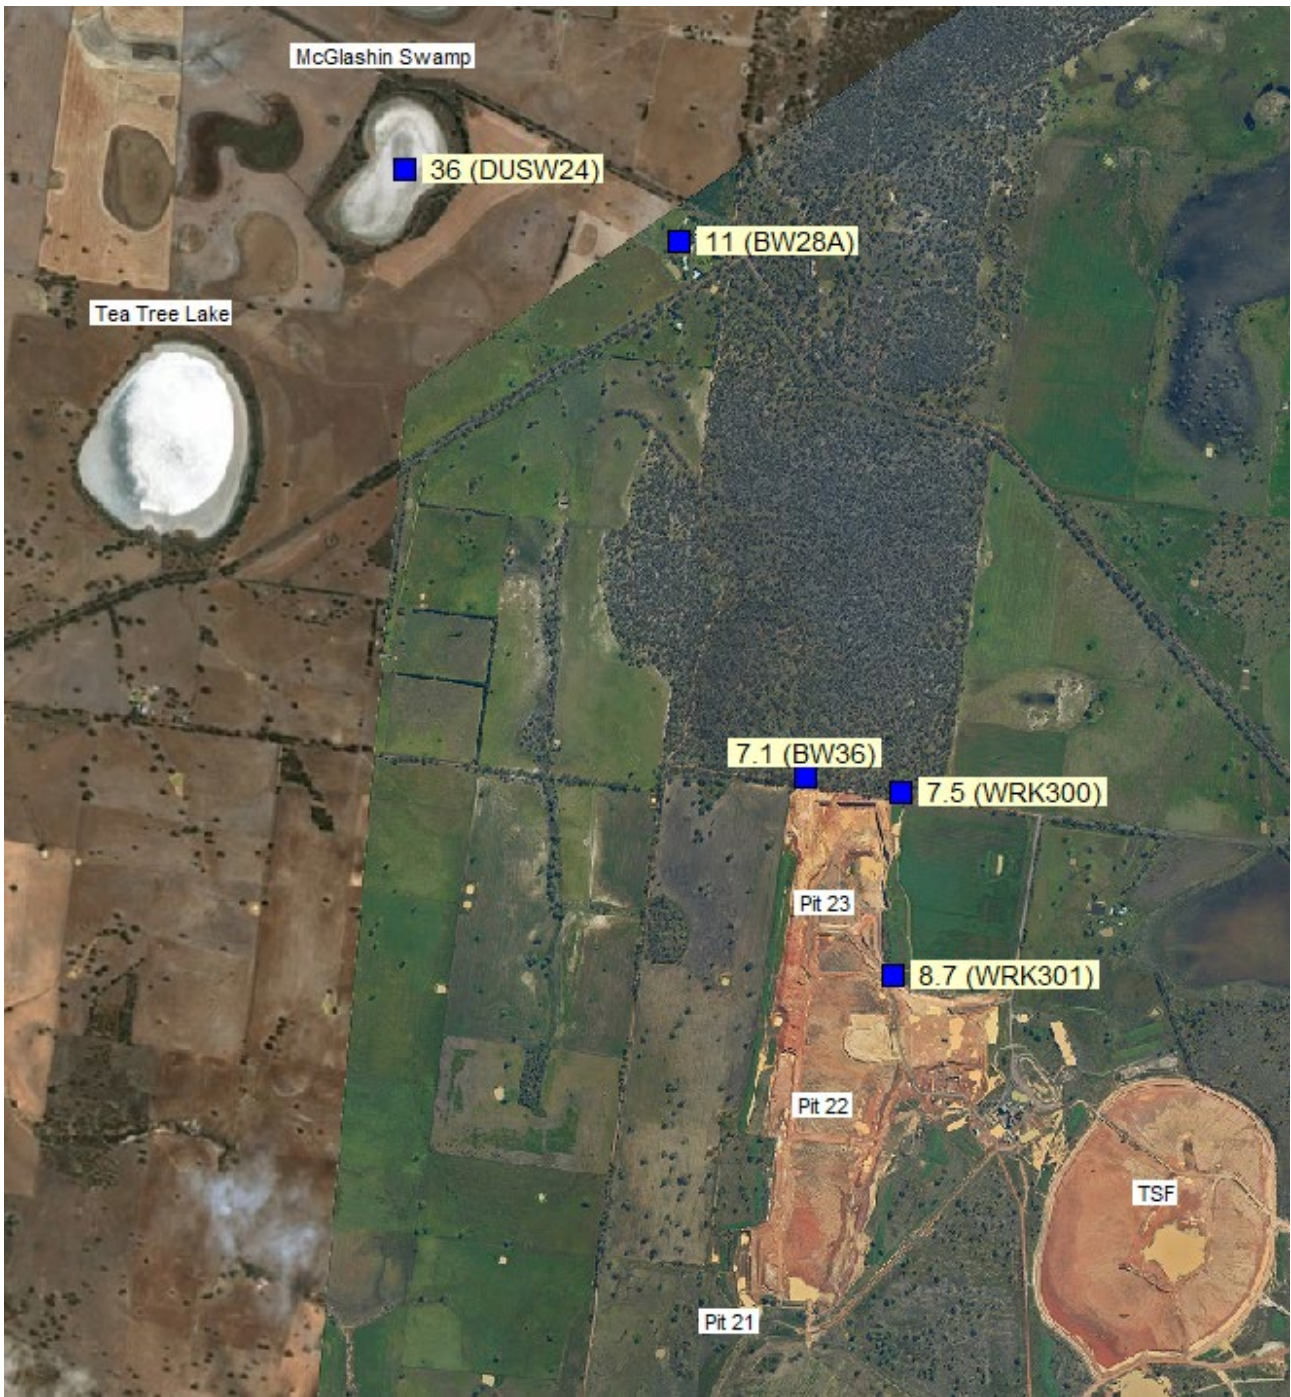
Figure 3.15 Locations and latest (2018)  $\text{Cl}:\text{SO}_4$  measurements of bores in or near the groundwater flow path from Pit 23 and at McGlashin Swamp (DUSW24)

- Cl:SO<sub>4</sub> measurements at McGlashin Swamp have been consistently higher than other groundwater-influenced surface water bodies since monitoring began in 2017. The high Cl:SO<sub>4</sub> is due to lower sulphate concentrations at McGlashin Swamp (1–72 mg/L) than other locations, suggesting that the water signature is not strongly affected by groundwater mixing which shows sulphate concentrations of 290–940 mg/L in the Pit 23 groundwater flow path; and

- Costello's Creek and the Northern Drainage Line exhibit much lower Cl:SO<sub>4</sub> levels around 10, which is similar to what is observed in groundwater.

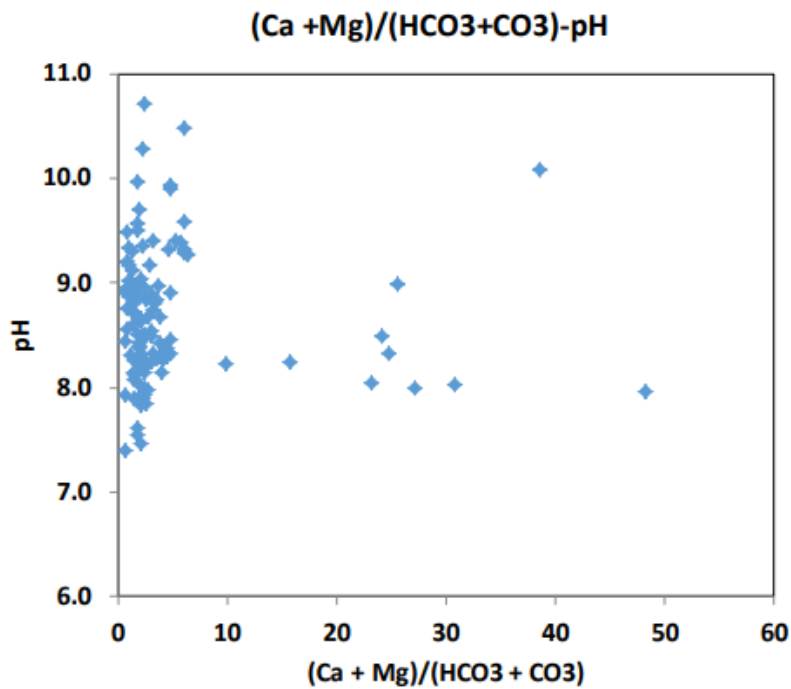
Figure 4.4 shows that ratios lower than approximately 10 will result in pH levels ranging roughly between 7.5 and 11.0, with most being in the 8.0 to 9.0 range. Table 4.2 shows the ratios calculated when considering McGlashin Swamp data collected in 2017 with ratios range from 0.64 to 2.97. This is considered very low, indicating that McGlashin Swamp would be expected to increase in pH caused by evapoconcentration.

**Figure 4.4** Sum of calcium and magnesium divided by the sum of carbonate and bicarbonate concentrations (meq/L) versus pH in wetlands (Reid & Mosley 2015)

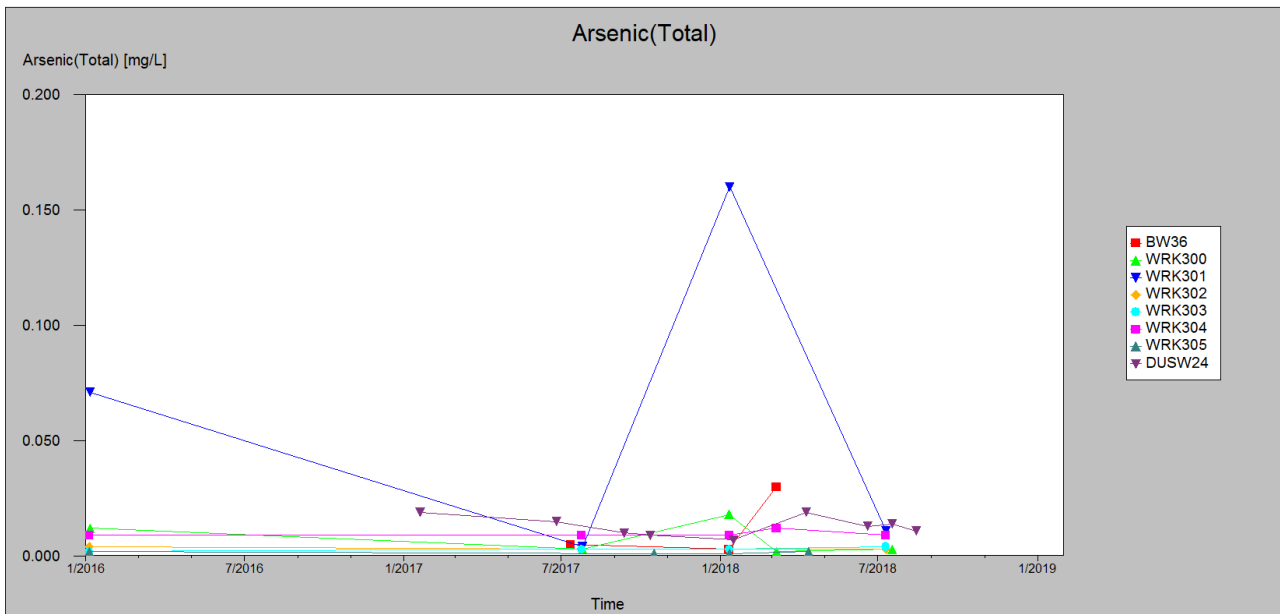
**Figure 5.6** Arsenic concentration (mg/L) in bores surrounding Pit 23 and within/near the groundwater flow path between Pit 23 and McGlashin Swamp
