Rehabilitation

Douglas

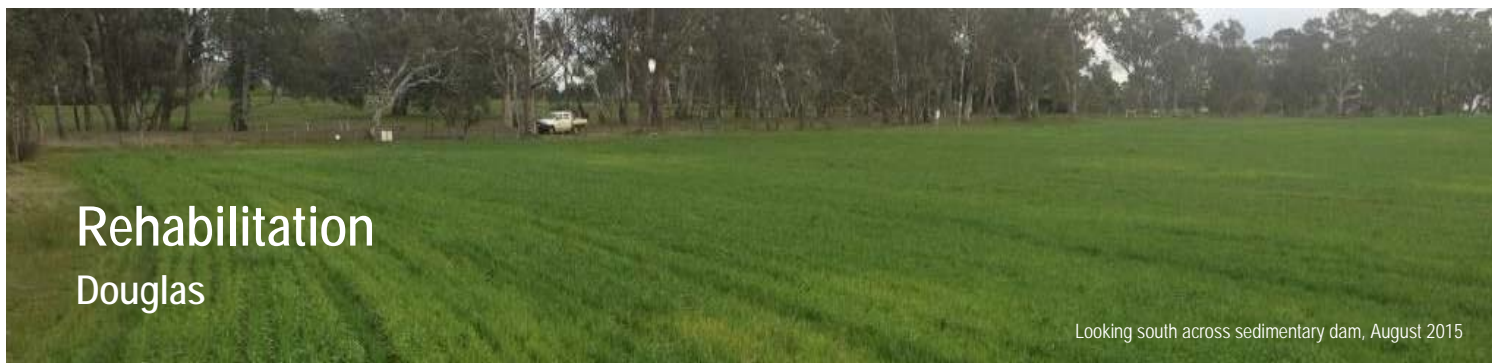
Looking south across sedimentary dam, August 2015

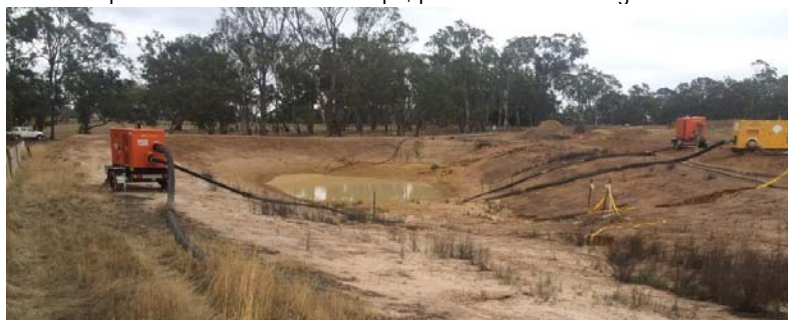
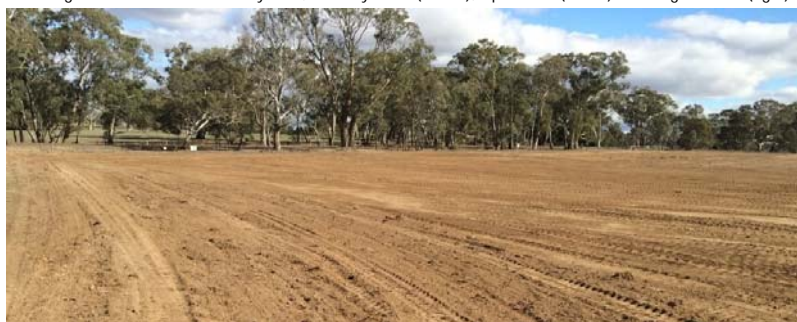
Looking south across sedimentary dam, January 2015 (above), April 2015 (below) and August 2015 (right)

In early 2014, Pit 19 south was profiled, rehabilitated and sown with crops. By the end of 2014, the soil at Pit 19 had stabilised to the extent that no further turbid water runoff would be expected. The sedimentary dam was subsequently returned to its original profile and now allows clean water runoff as it did prior to mining.

Rehabilitation of the dam required the replacement of overburden, subsoil and topsoil before fertiliser and sowing of oat crop. The area has been stable throughout 2015 and yielded a good oat crop. Sheep will be grazing the area in early 2016.
